Work Request Follow-Up Report Vibration Analysis

Area 700 Power Generation G745A Liquid Ring Vac Pump

Pump DE bearing Damage
(Corrosion)

June 2015

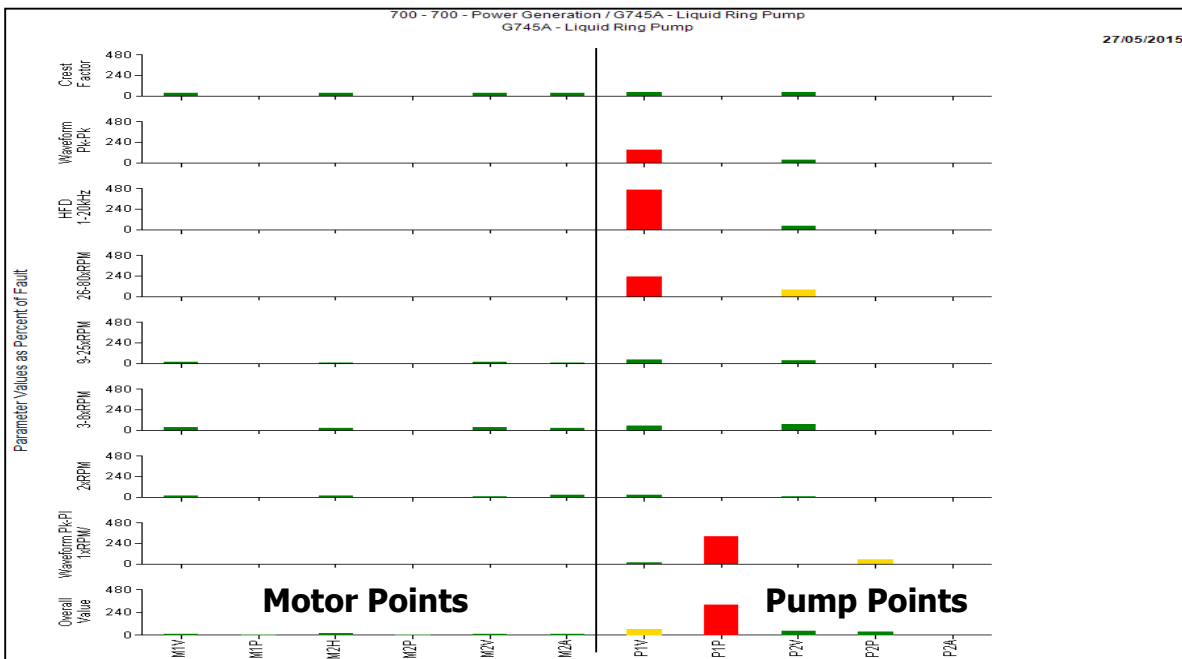
The parameter profile above is a graphical representation of the vibration alarms which have been broken across the machine. Note the high levels on the pump DE bearing, recorded on the 27th May 2015, the first set of data collected.

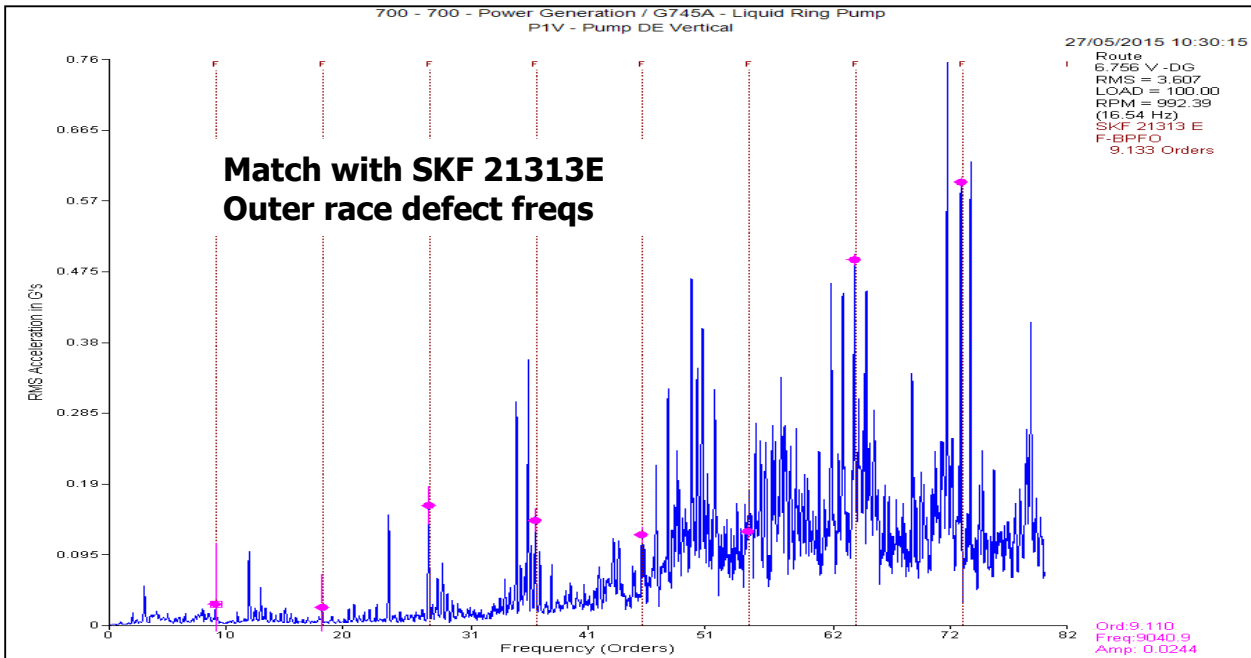
Analysis of the standard spectrum above taken from the pump DE bearing showed a set of non-synchronous harmonics at 9.11 orders of turning speed. This matched the outer race defect frequency for the SKF 21313E pump bearing, other harmonics were also present related to the Inner race and roller defect frequencies. This indicated the bearing had multiple defect sites.

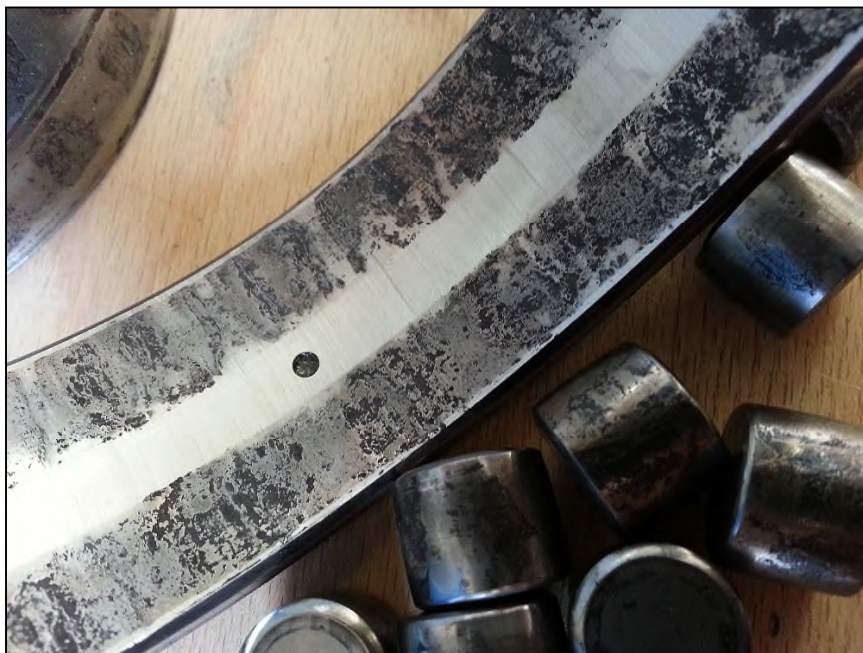
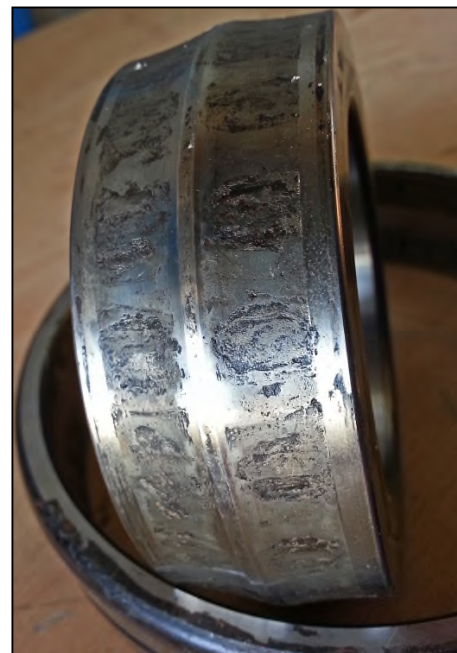
Analysis of DE Vacuum Pump Bearing – SKF 21313 E

Greyish black streaks and marking on all rolling element surfaces, heavy pitting and cracking

Presence of water / moisture in the bearing over a long period of time.
Most likely due to poor pump storage before operation, lack of adequate seal arrangement at the DE is also a contributing factor

Store equipment in suitable a location before fitment and rotate periodically.
Consider modification of DE pump brg sealing arrangement.

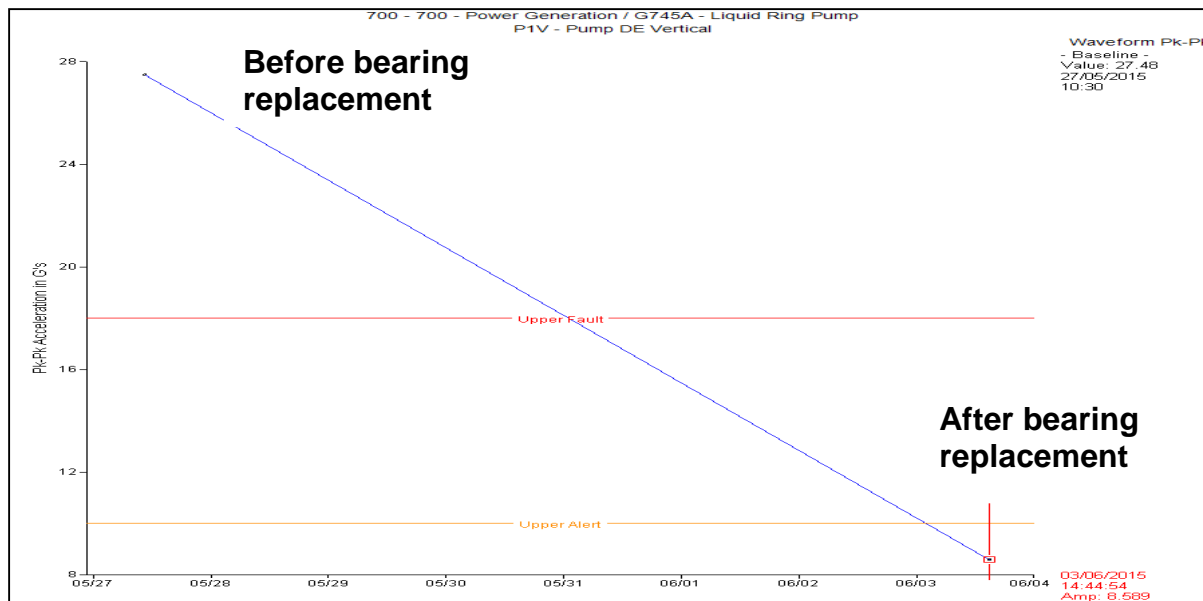
The vibration trend above (Waveform PK-PK G's) shows a clear drop in G levels after the pump bearings were replaced in early June.
