## Low Speed Trunnion Bearing Problems

Dean Whittle

## ANIMAL FEED DRYER PLANT

### Case Study 1 - **Trunnion Bearing Problem**

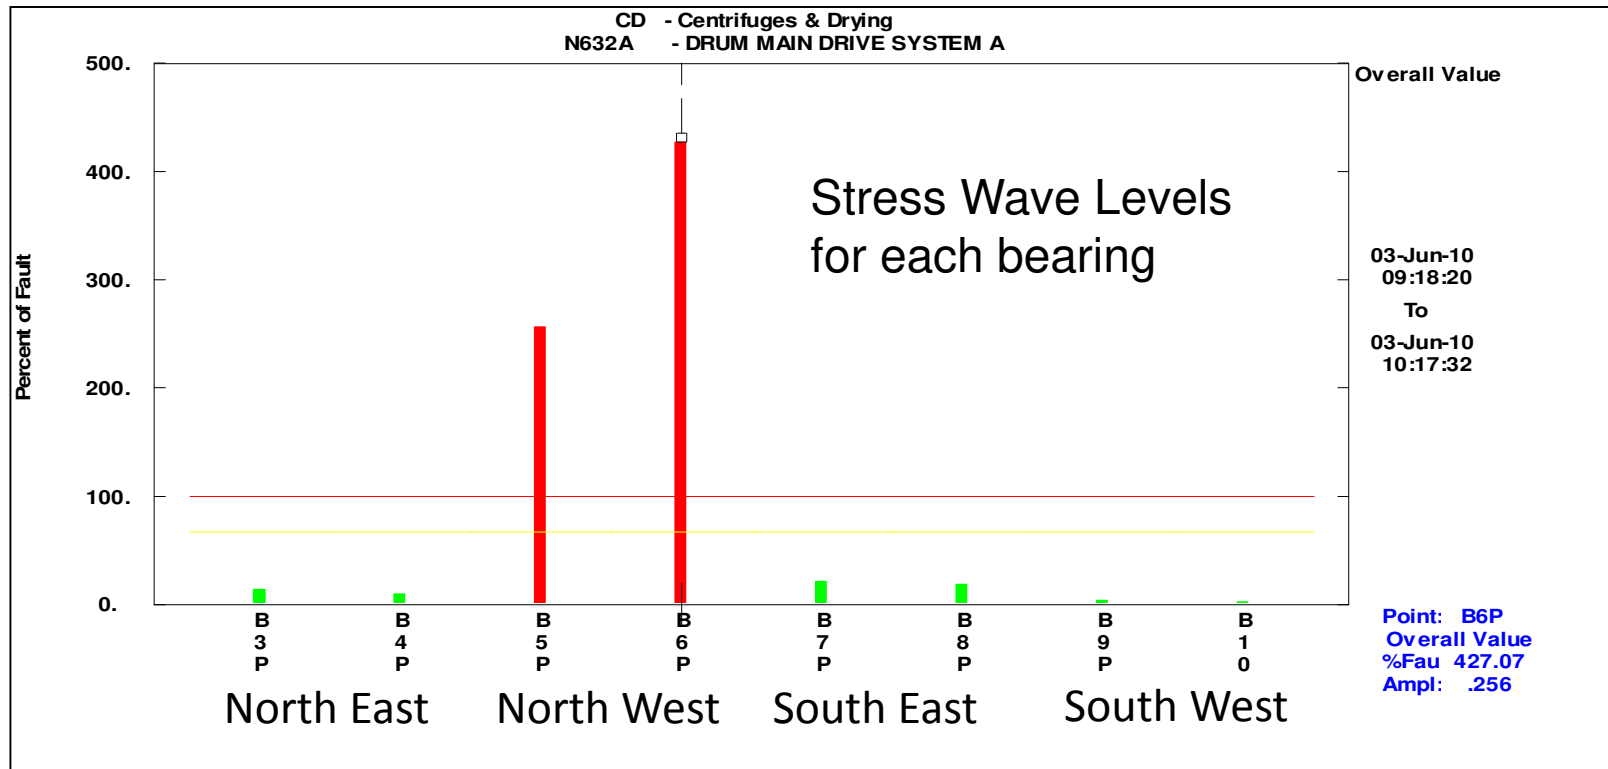
- PeakVue Overall Stress Levels in G's
- **Data showed raised impacting levels on North West Bearings.**

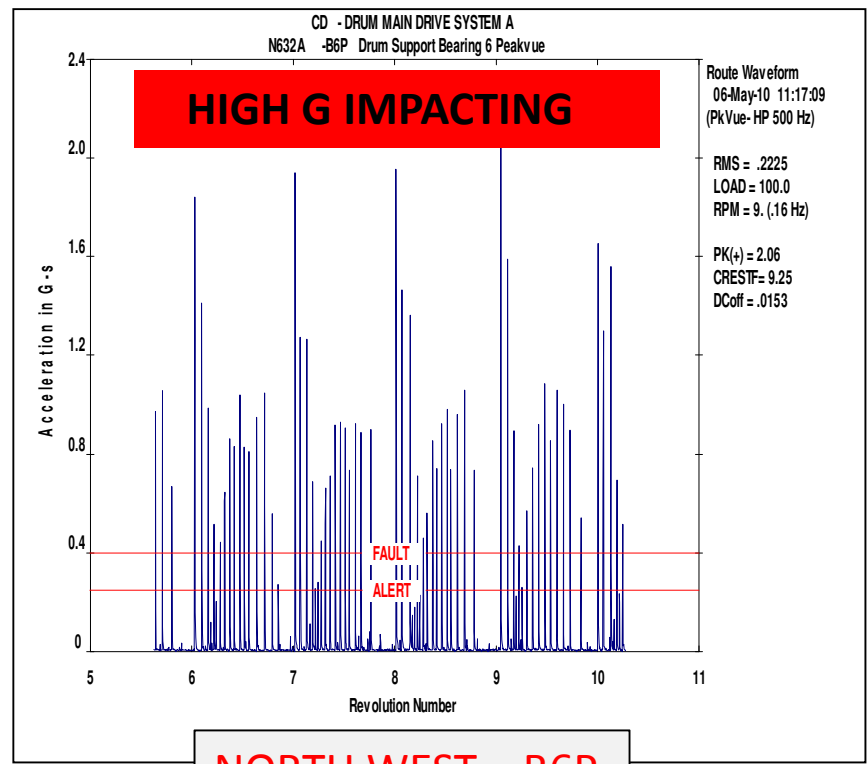
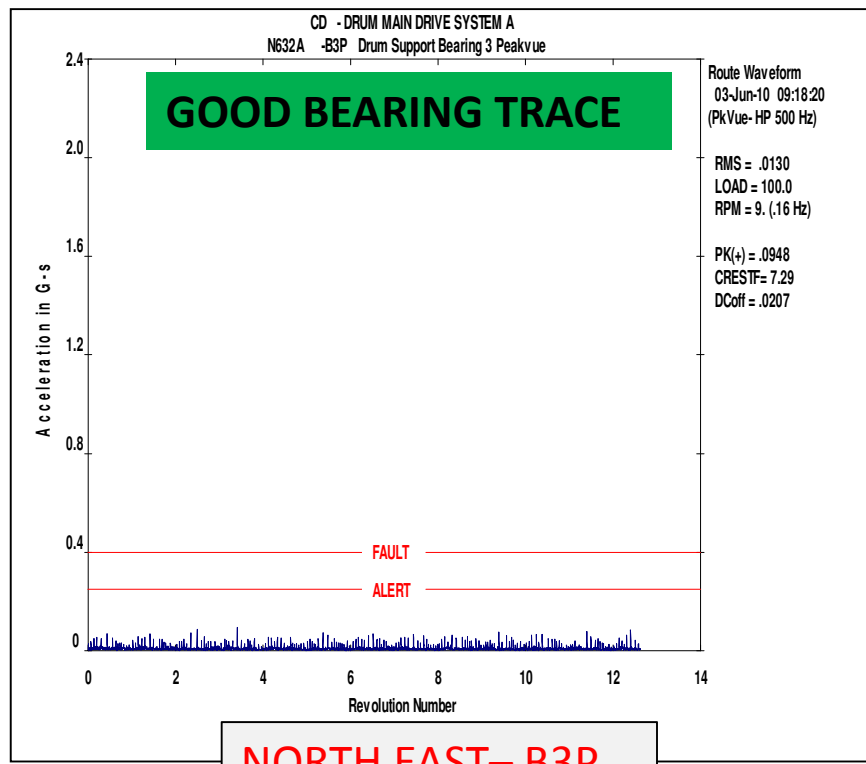
- **Comparison Time Waveforms, High G Stress Wave** impacting on the North West Bearing Pair

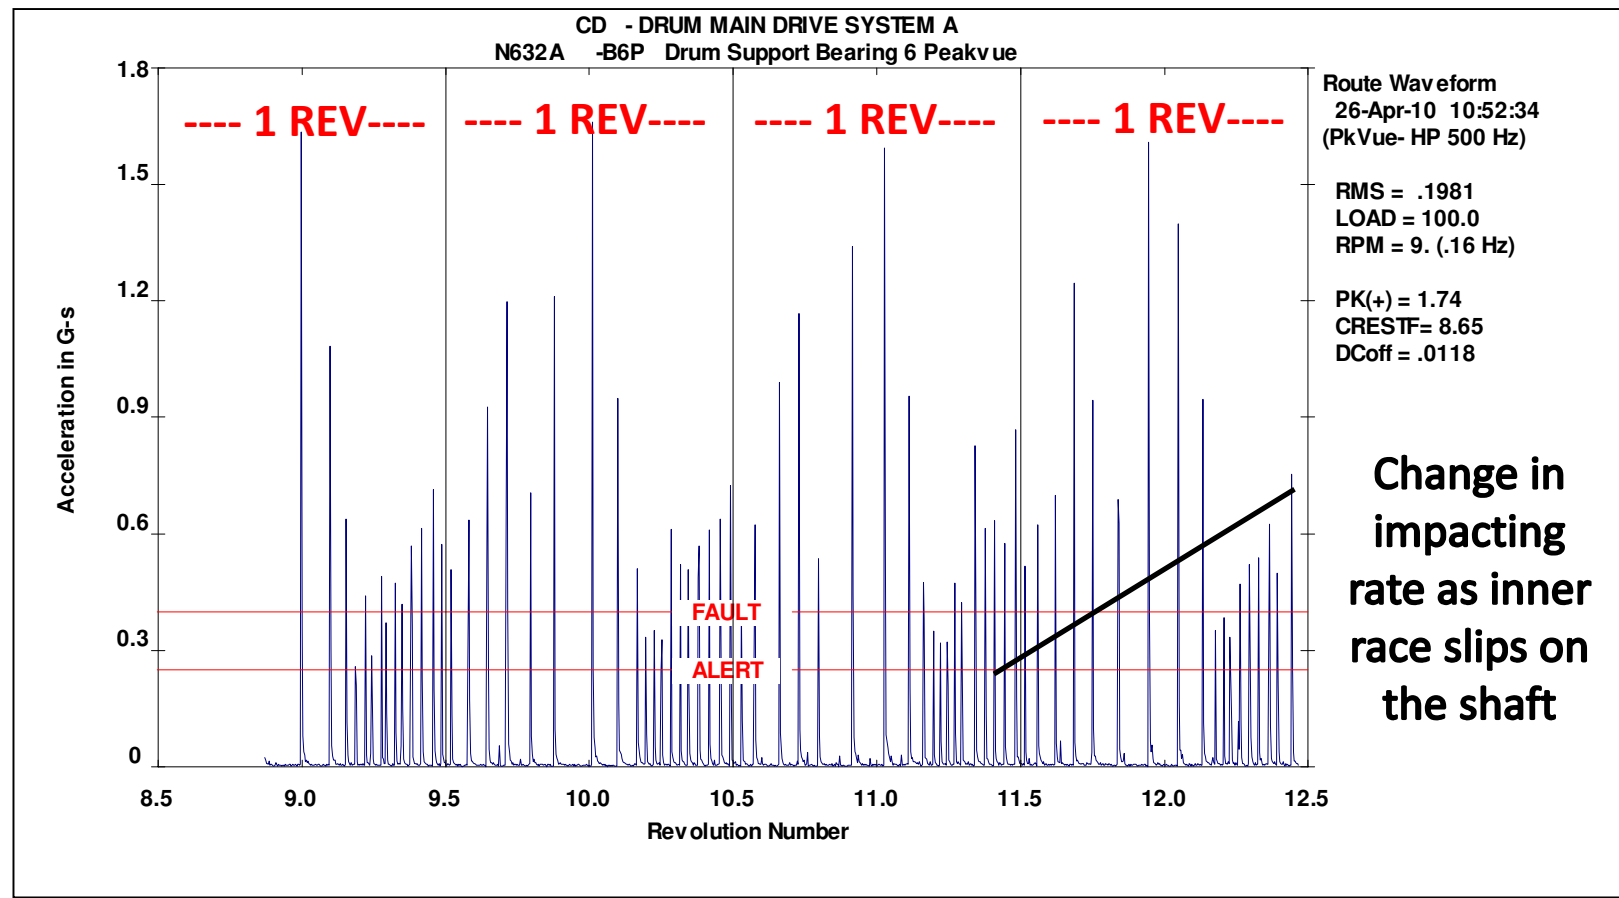
- B6P North West showed highest levels.
- Data pointed to an **INNER RACE PROBLEM** as impacts were modulated at 1XRPM (Due to rotation of inner race) many harmonics from 9.5 CPM (Shaft turning speed)

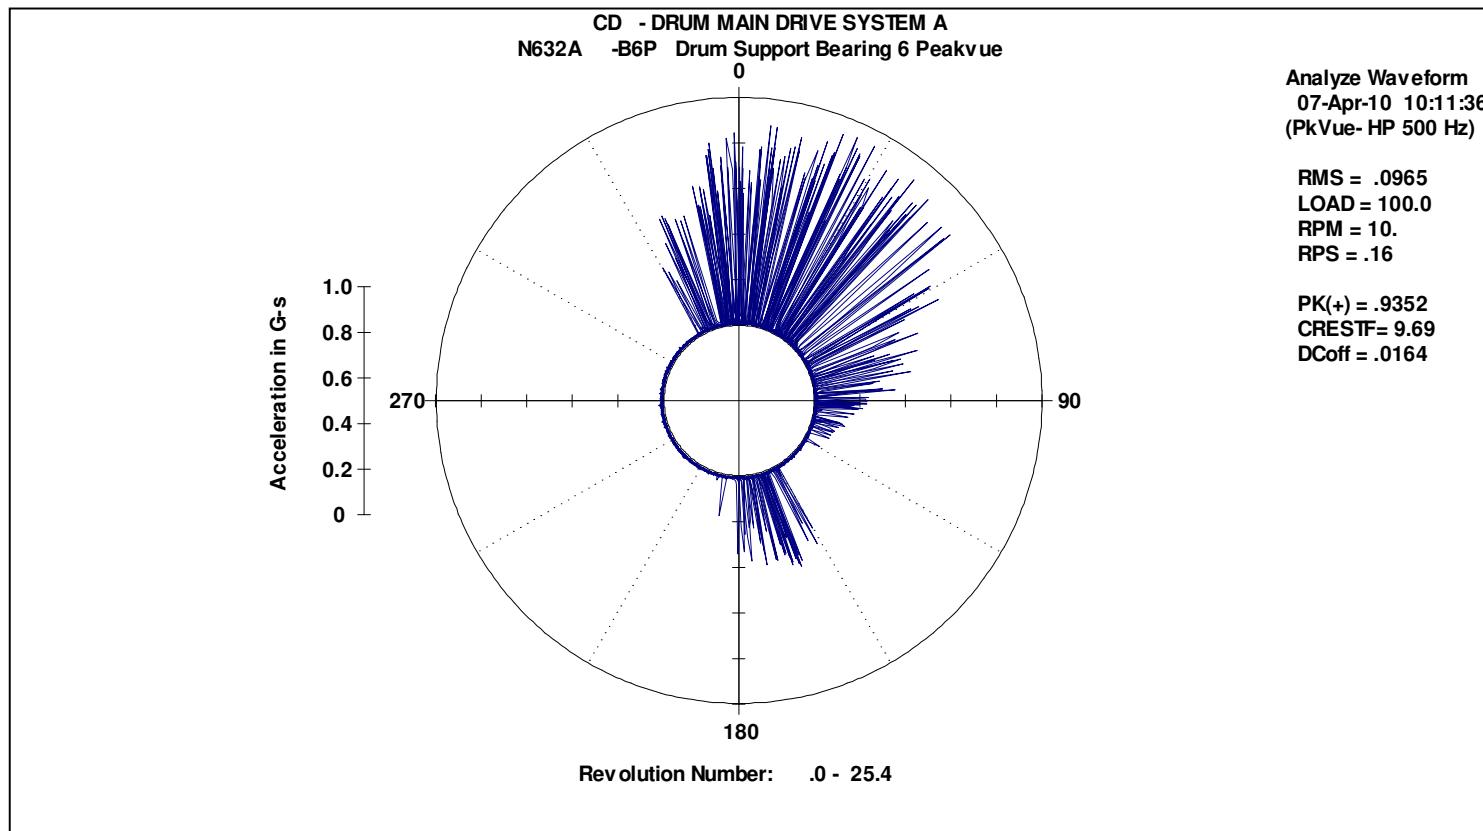
- B6P North West showed highest levels.
- Data pointed to an **INNER RACE PROBLEM** as impacts were modulated at 1XRPM (Due to rotation of inner race) many harmonics from 9.5 CPM (Shaft turning speed)

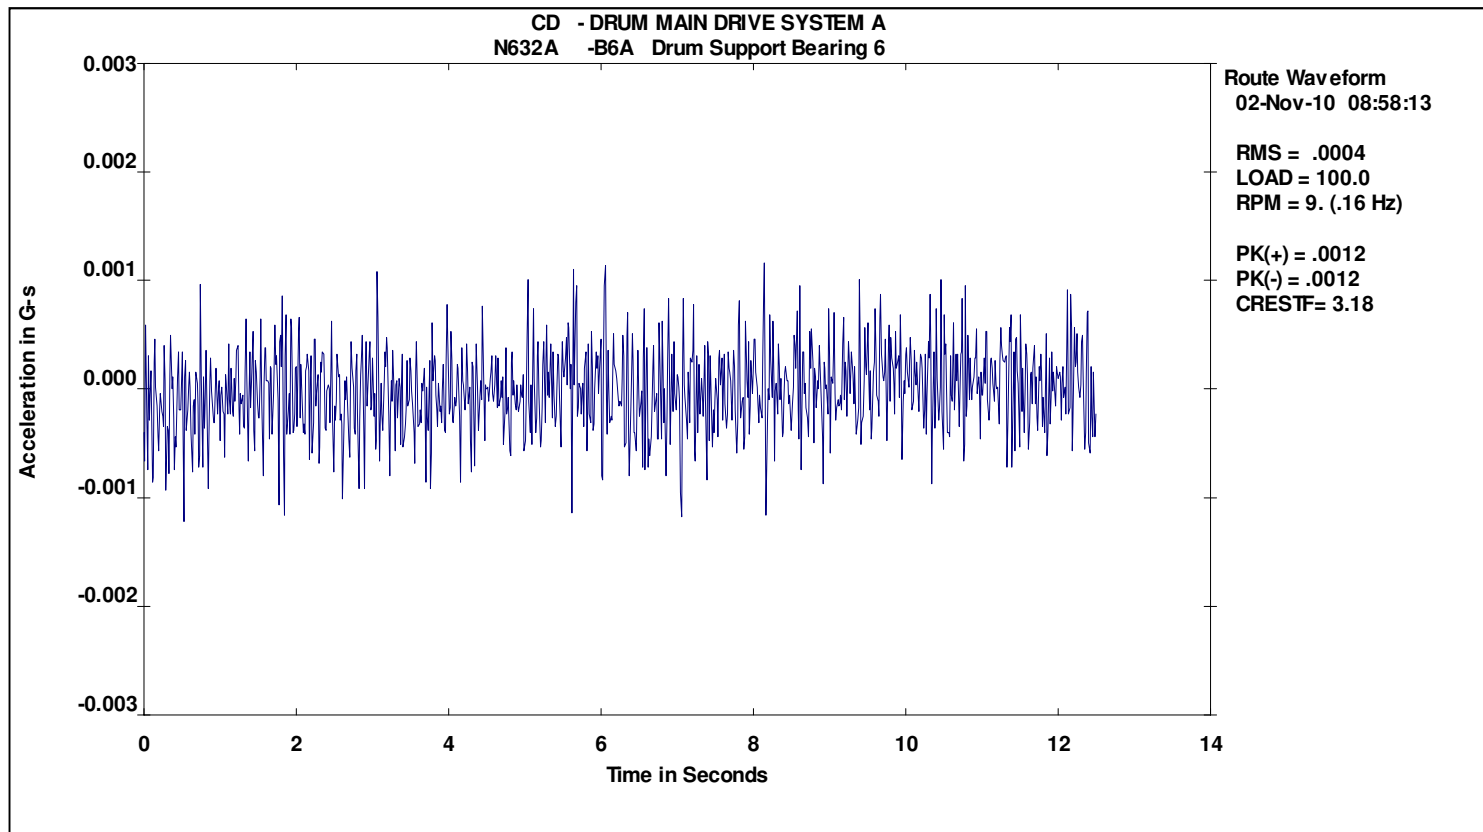
- B6P North West Standard Data
- Data showed no impacting evident

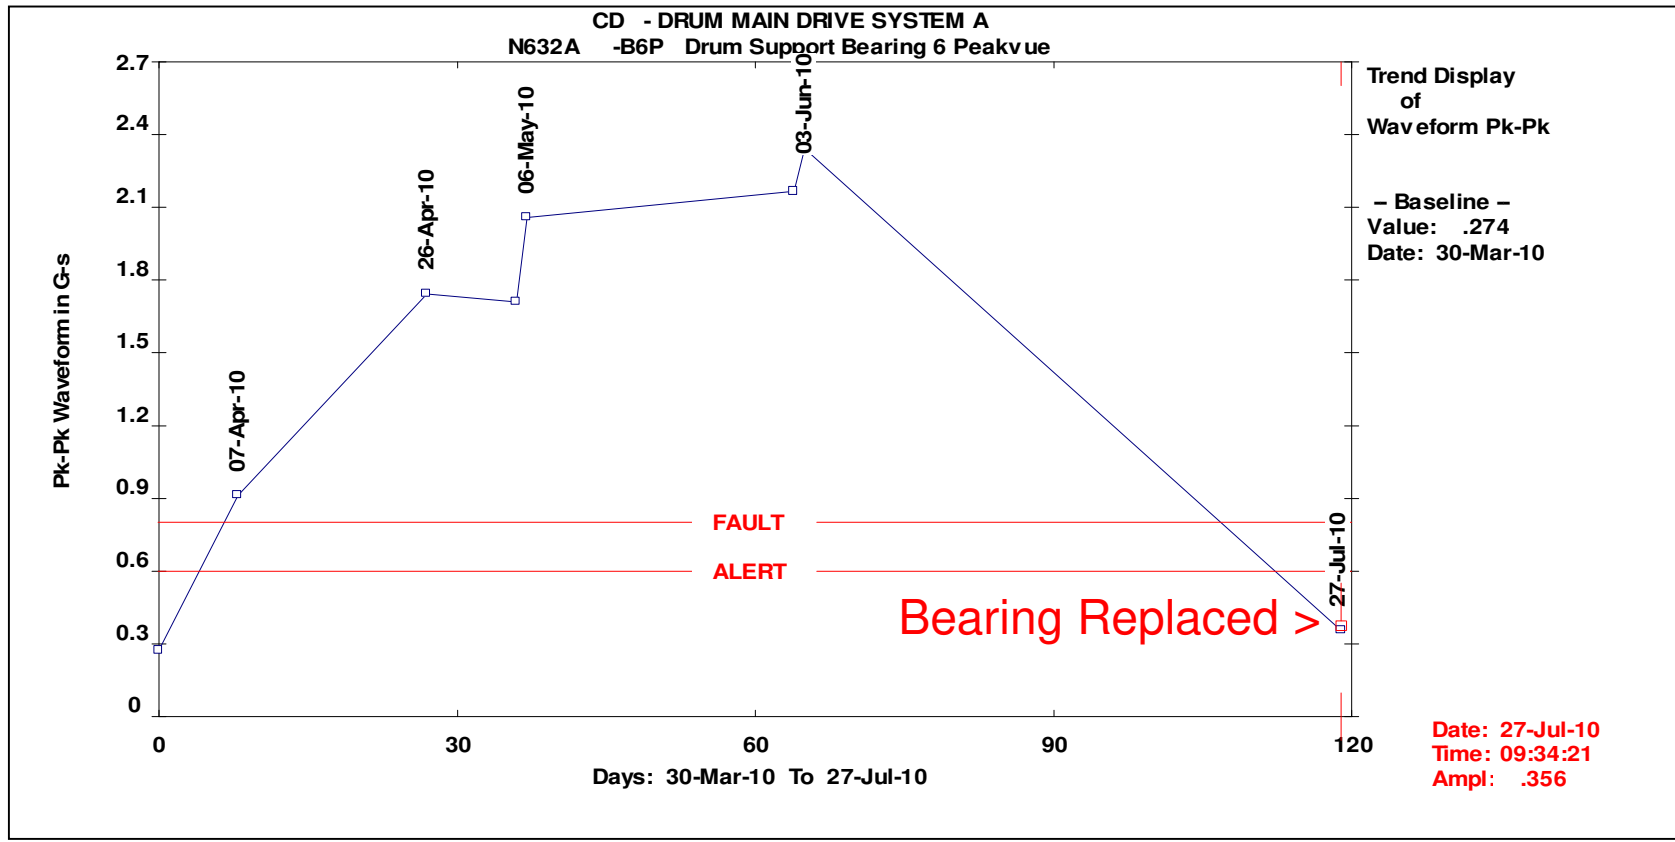
- **PeakVue Waveform PK-PK Trend** showed increasing levels over a 3 month period, 0.3 G's to 2.3 G's **RMS recommended North West Trunion replacement at July Shutdown**

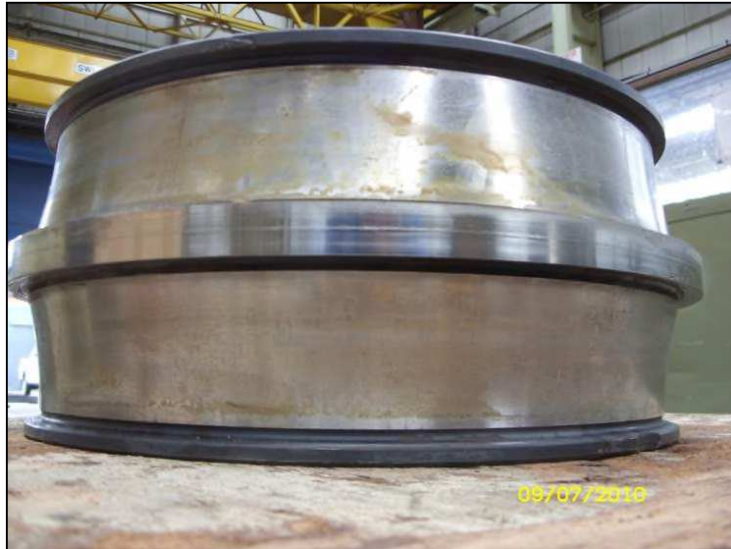
The inner race bearing track shows some slight staining but no surface damage could be identified.

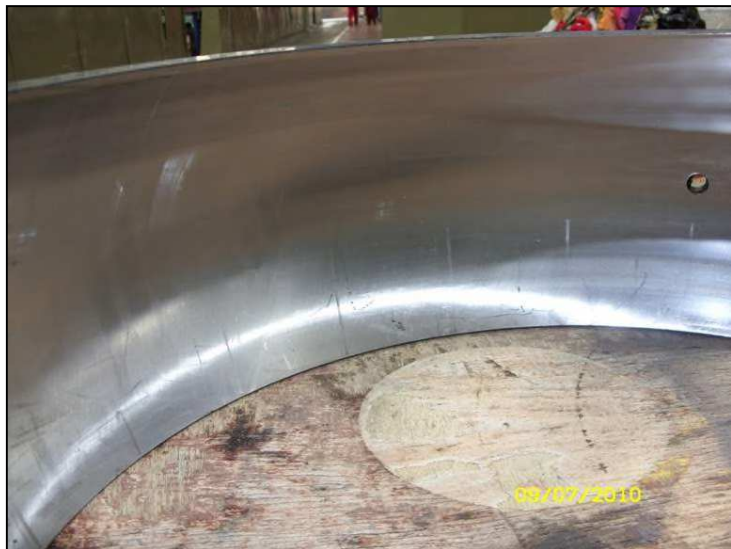
The outer race inside diameter shows some indentation damage. The vertical lines on the surface match the roller spacing.

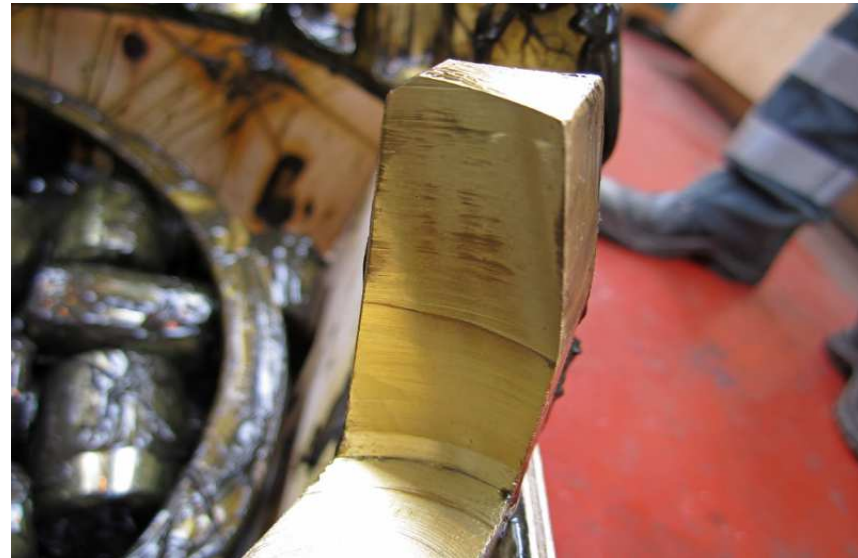
The cage needs to be cleaned to allow more detailed analysis. The grease is much darker in colour than the new grease and is contaminated with brass particles.

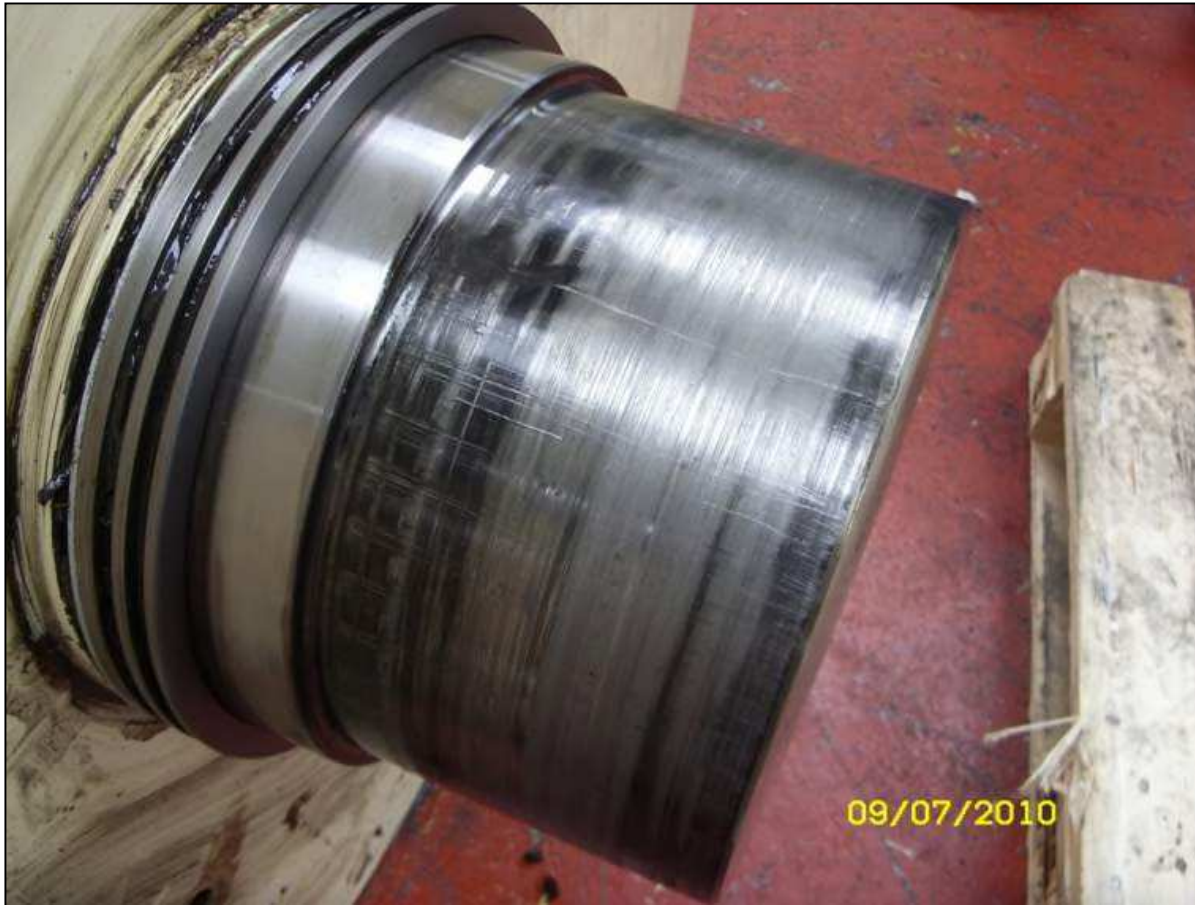
- **Root Cause – Poor inference between inner race and shaft**

**Roller Shaft –  
Horizontal scratches  
occurred during the  
removal of the bearing.  
The Damage around  
the surface of the  
bearing contact area is  
due to the bearing  
inner race rotating on  
the shaft.**

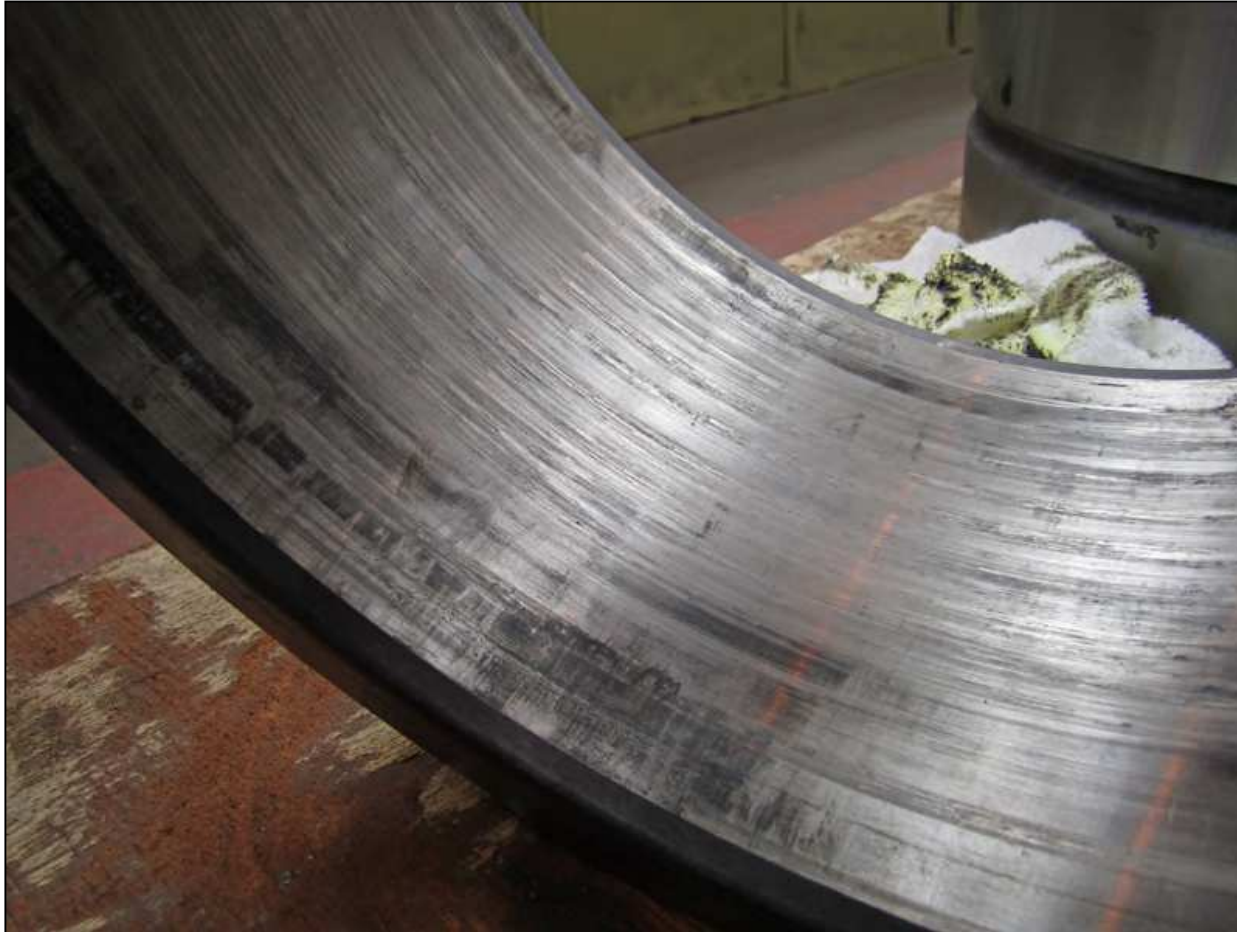
The inside diameter of the bearing inner race shows rotational damage

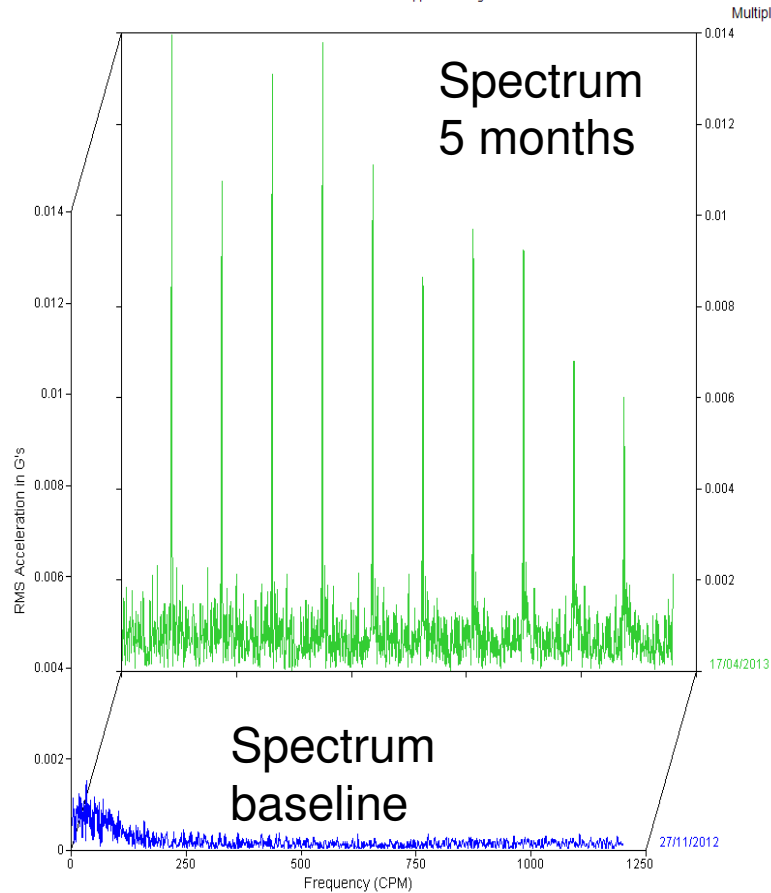
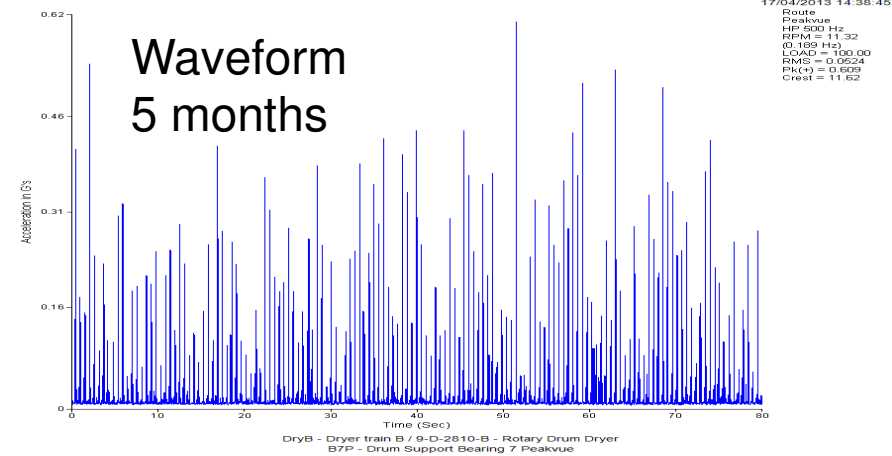
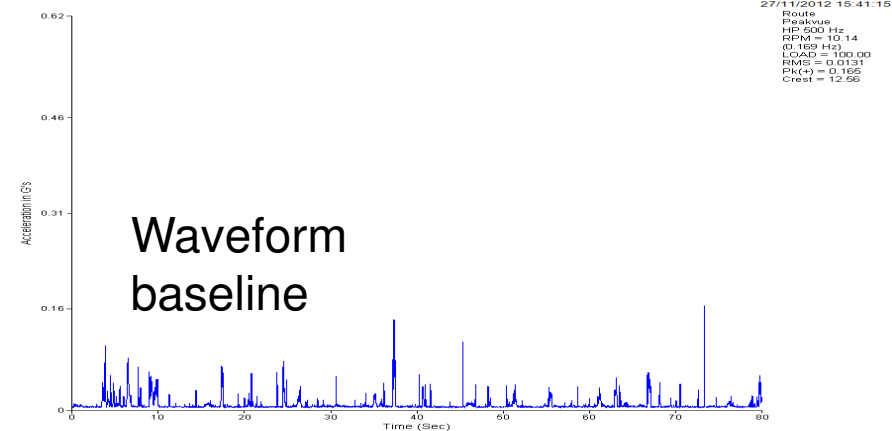
- Increase in spectral & waveform activity after 5 months of running on **B7P** bearing

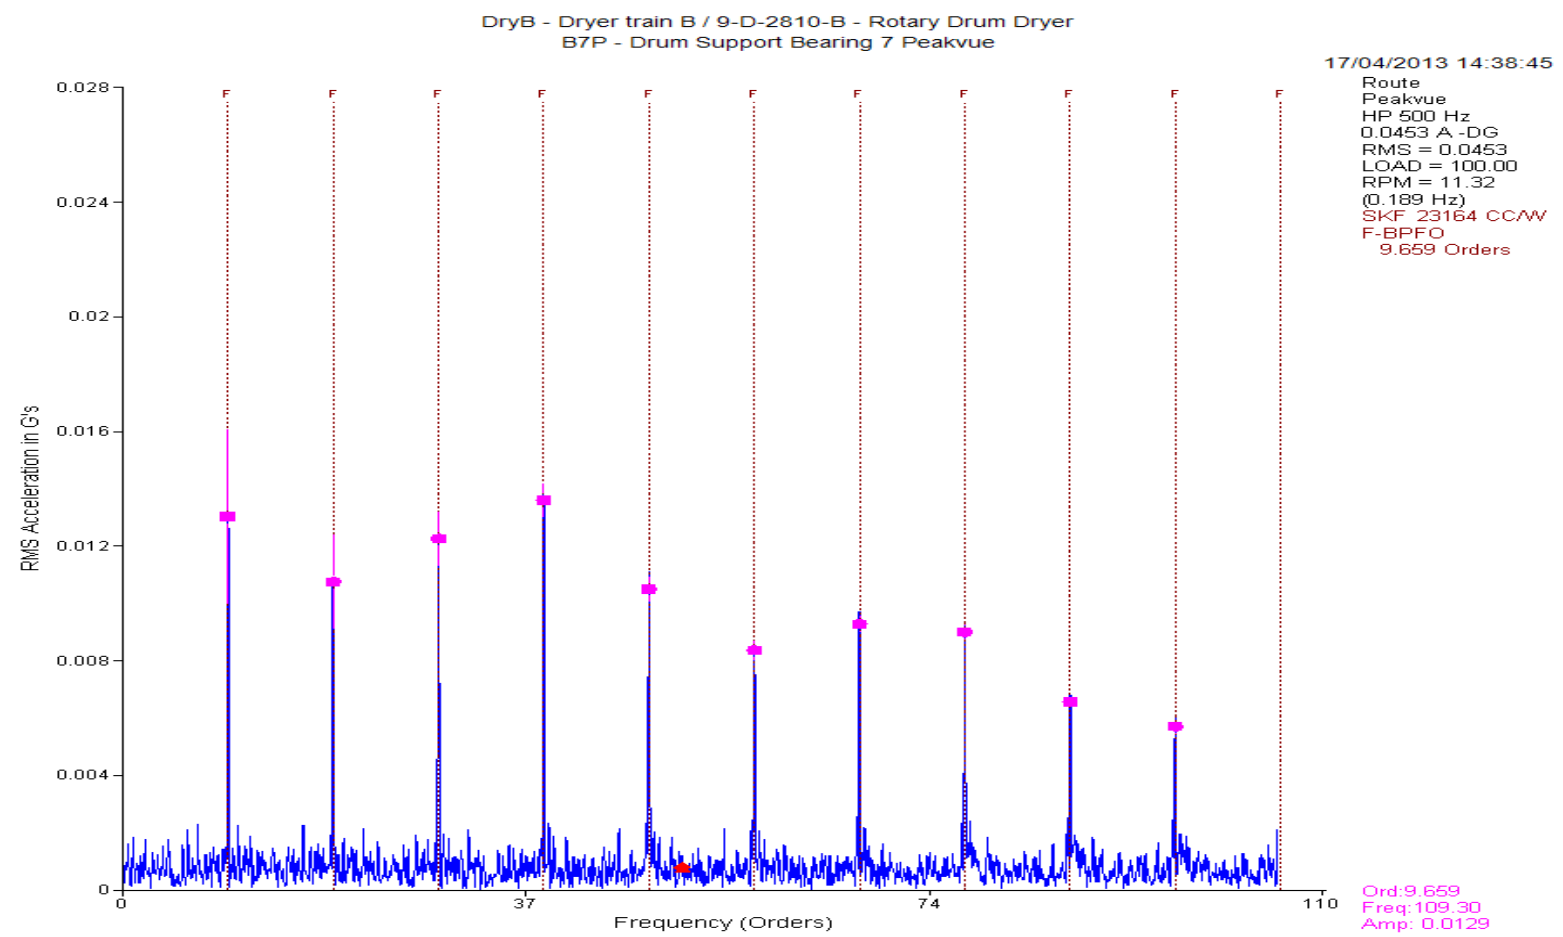
- Spectral data shows perfect match with **outer race defect freq for SKF 23164 CC/W (9.65 Orders)**

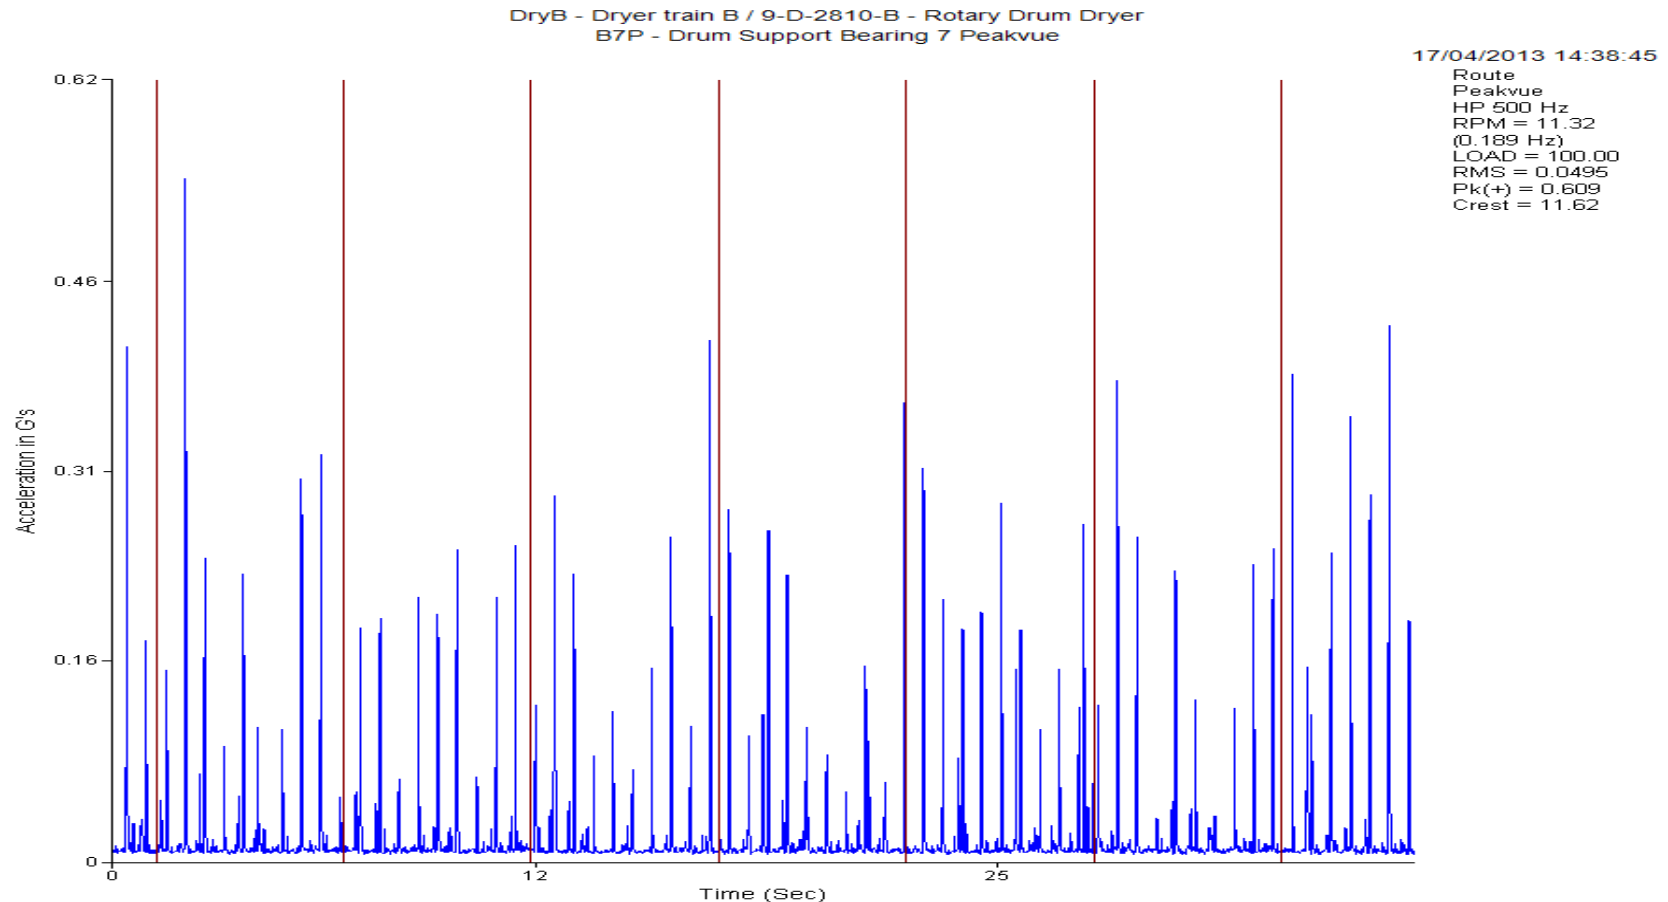
- Time waveform data shows impacts spaced at outer race defect frequency raised G levels.

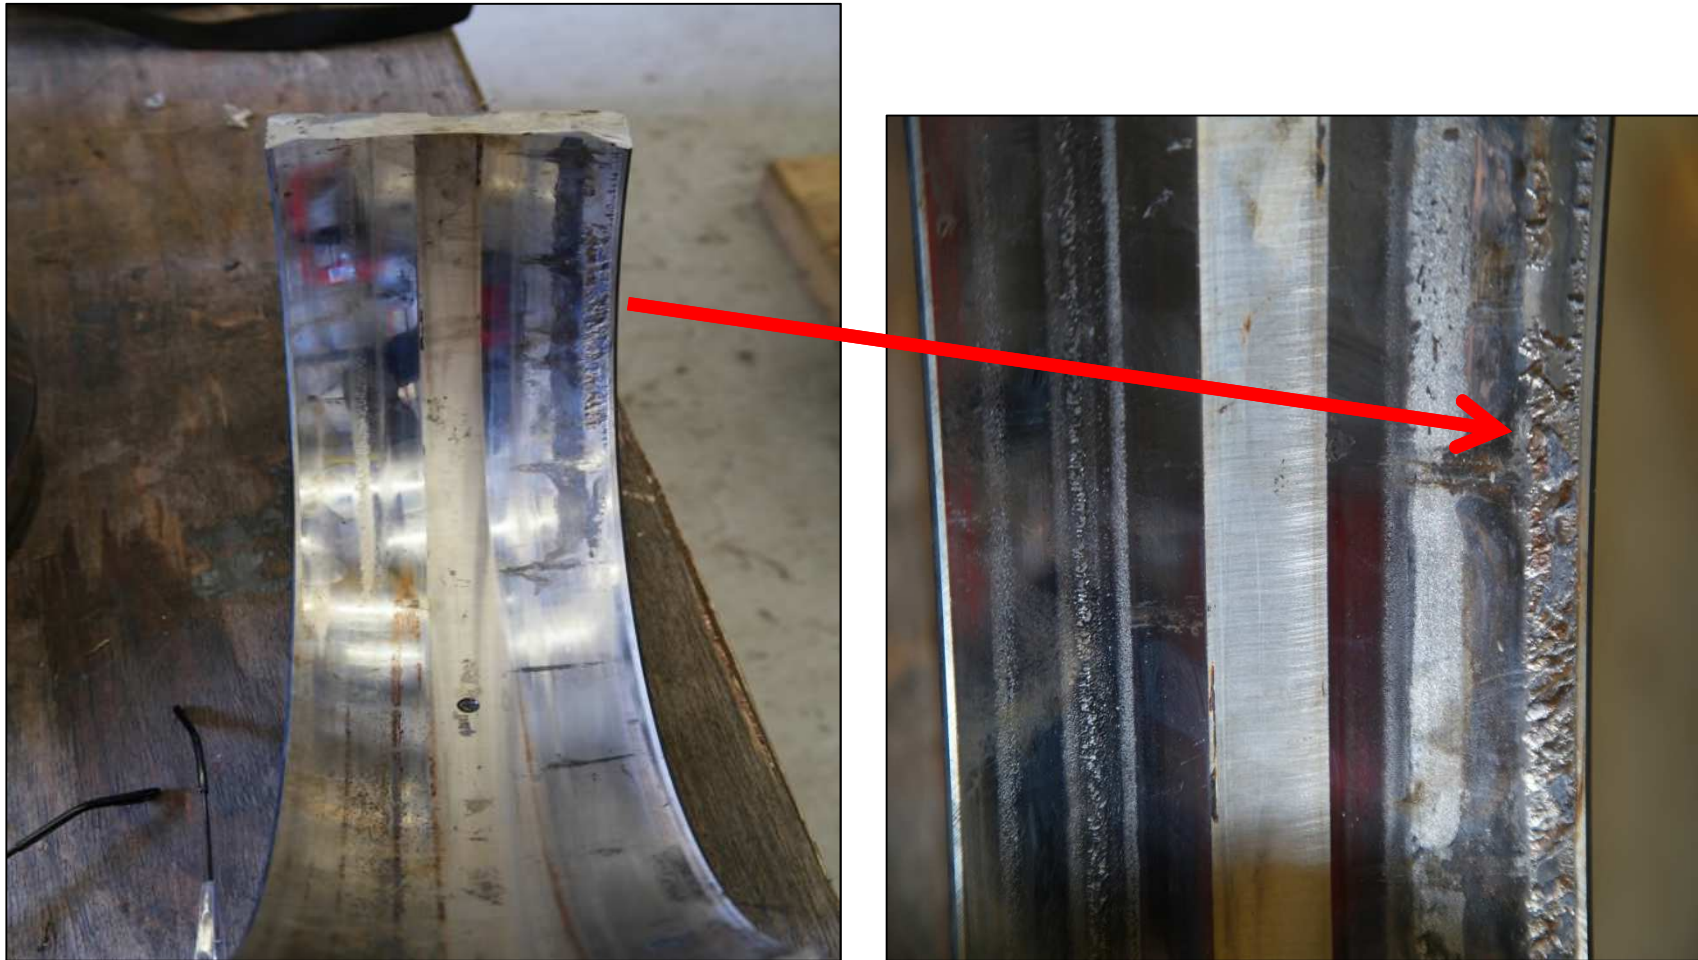
- Inspection found advanced spalling on the outer race of the SKF 23164 CC/W bearing

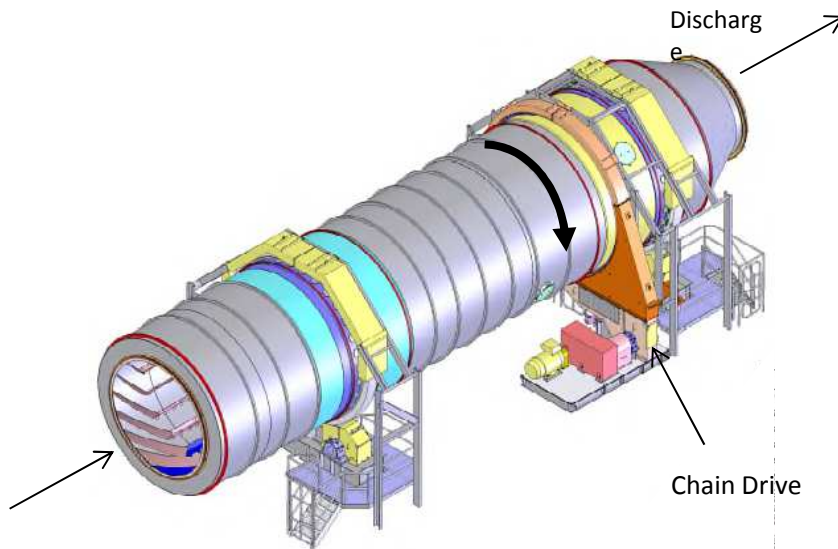
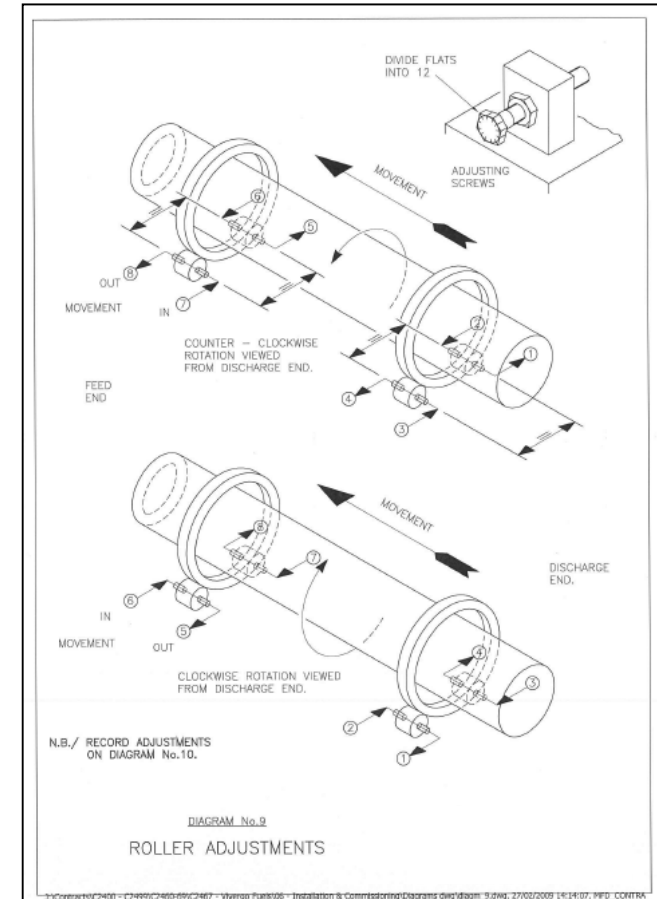
- Bearing was sent away for detailed analysis
- Bearing damage was caused by **Excessive axial loading**
- Further investigations found **Incorrect alignment** of the trunnion bearings
