# Primary Air Fan COGA Unit

## Fault Analysis Report

## 5031-7010 Primary Air Fan (Fan DE Bearing Problem)

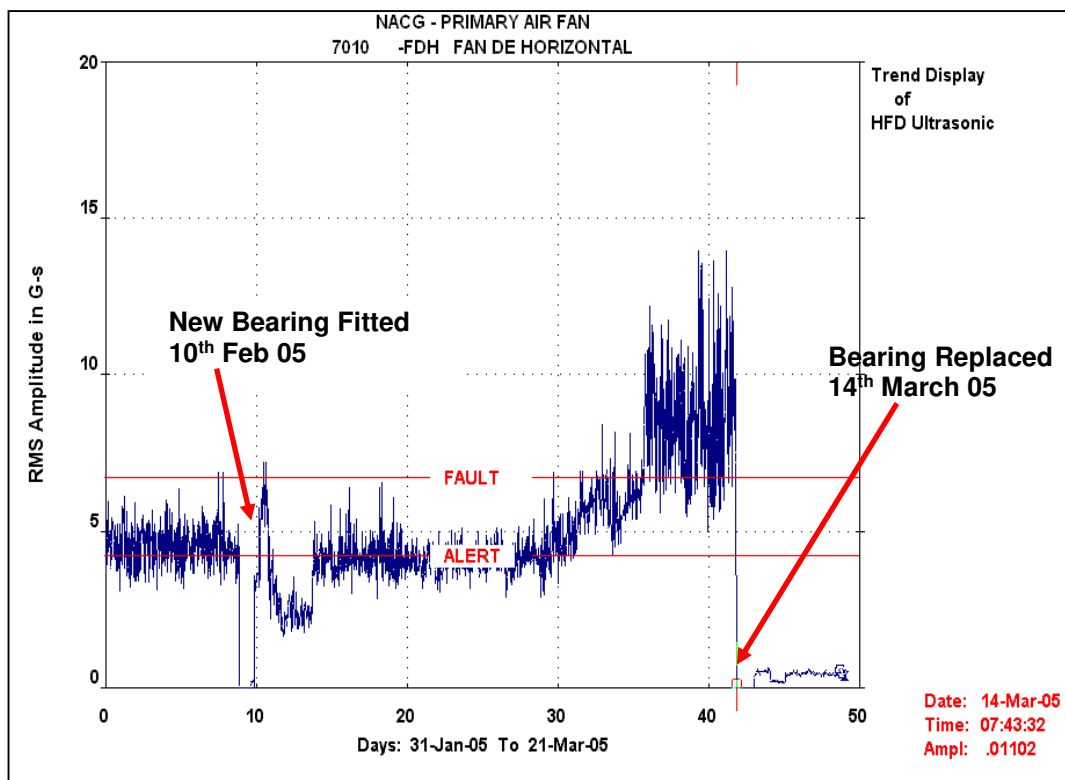
The above online trend is taken off the Fan DE bearing; the HFD levels were increasing steadily until the bearing was replaced on the 14<sup>th</sup> March 2005. HFD levels respond to bearing distress and lubrication problems.

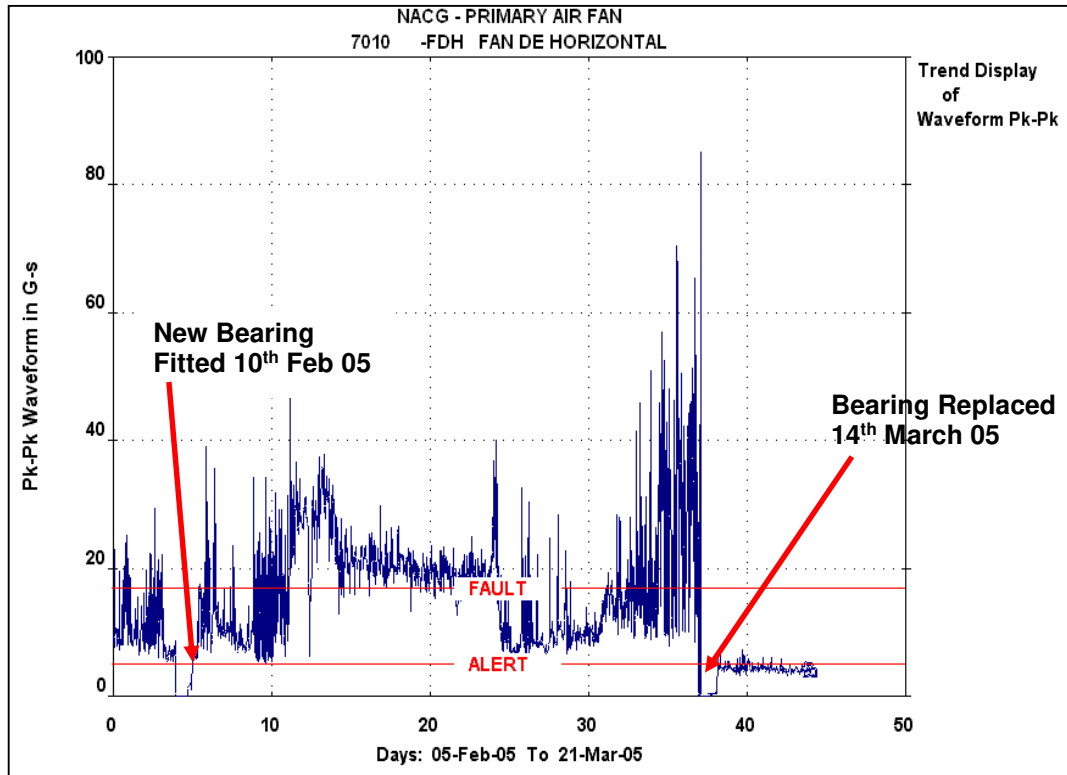
The above online trend is also taken from the Fan DE bearing, this is a different parameter, the PK-PK Waveform level measured in G's, this responds more to impacting problems such as bearing defects, note how the levels increased sharply before the bearing was replaced

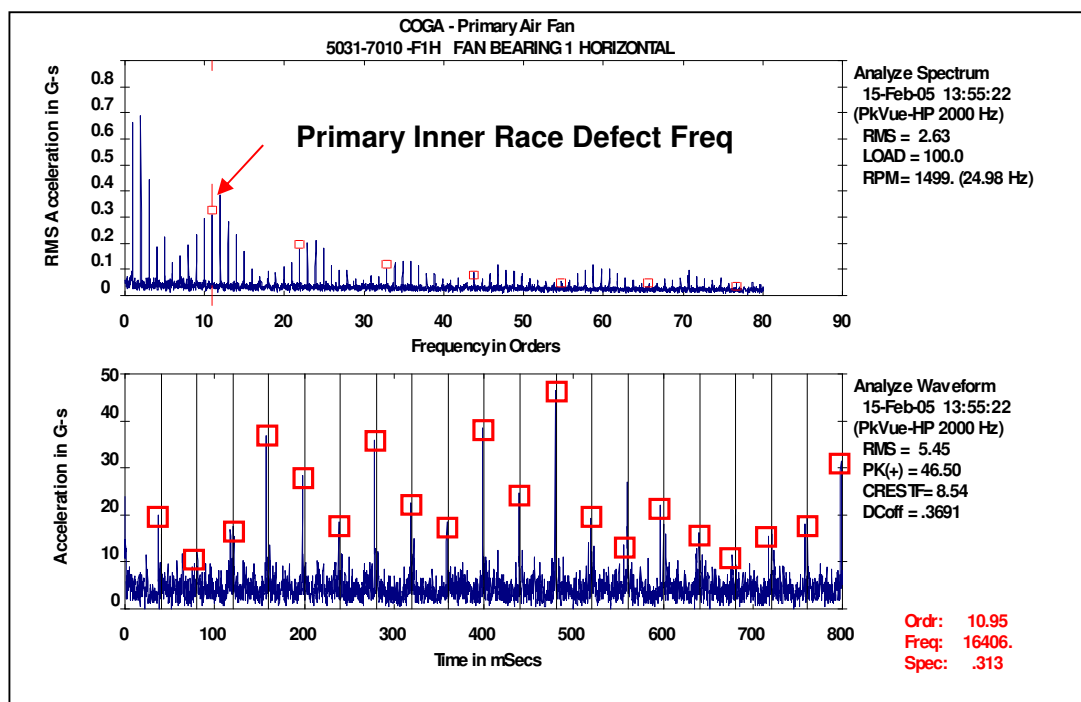
Analysis of spectral and waveform data from the Fan DE bearing clearly showed a severe impacting problem, a dominant once per rev impact was present on the waveform, these graphs were typical of an inner race defect in a localised defect site.

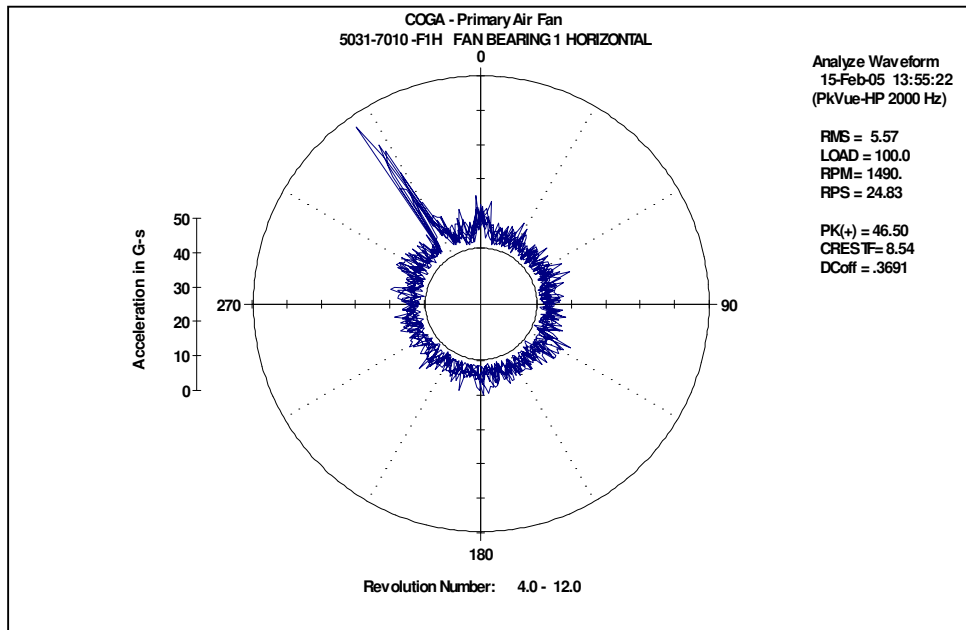
Further Analysis of the waveform using the rotational plot clearly shows the impacting was localised in one position on the inner race.

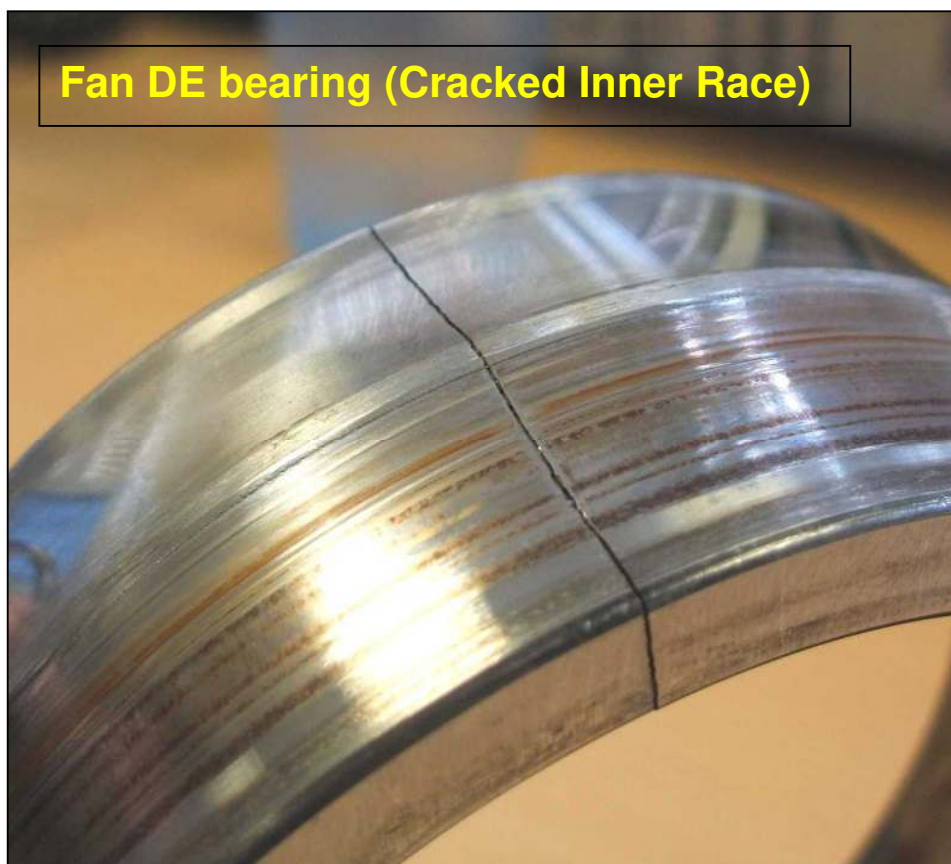
Upon inspection of the fan drive end bearing, a clear crack across the full width of the race was found, this was the source of the high G' impacting levels. The sharp spikes seen on the data were the bearing rollers impacting the crack.

Excessive tightening of the lock nut upon assembly is the most likely caused of the cracked inner race, however a manufacturing fault cannot be ruled out, having the cracked inner race examined should reveal the root cause. Poor lubrication of the fan bearing is also a potential issue and this should be addressed.

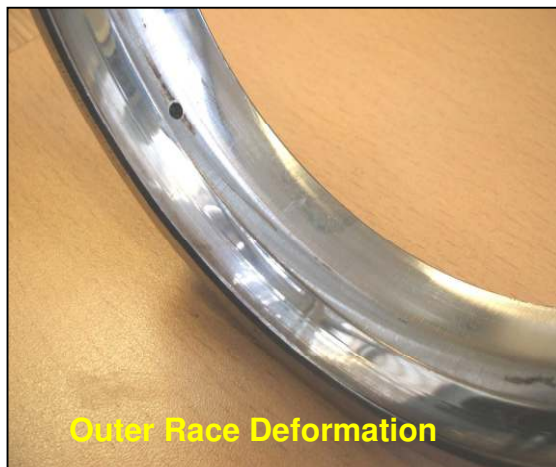
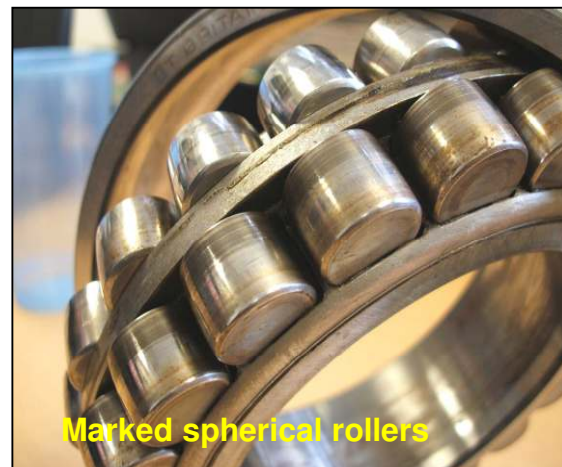
Further examination of the bearing also revealed deformation of the outer race roller path surface and scoring to the rollers (loaded side). It was also noted the condition of the grease within the bearing was poor, indicating a potential lubrication issue as well as the cracked inner race.
