# **COGA Unit Flue Gas Recycle Fan 5031-7035**

## **Online Vibration Case Study**

## 5031-7035 Flue Gas Recycle Fan (Online Case Study)

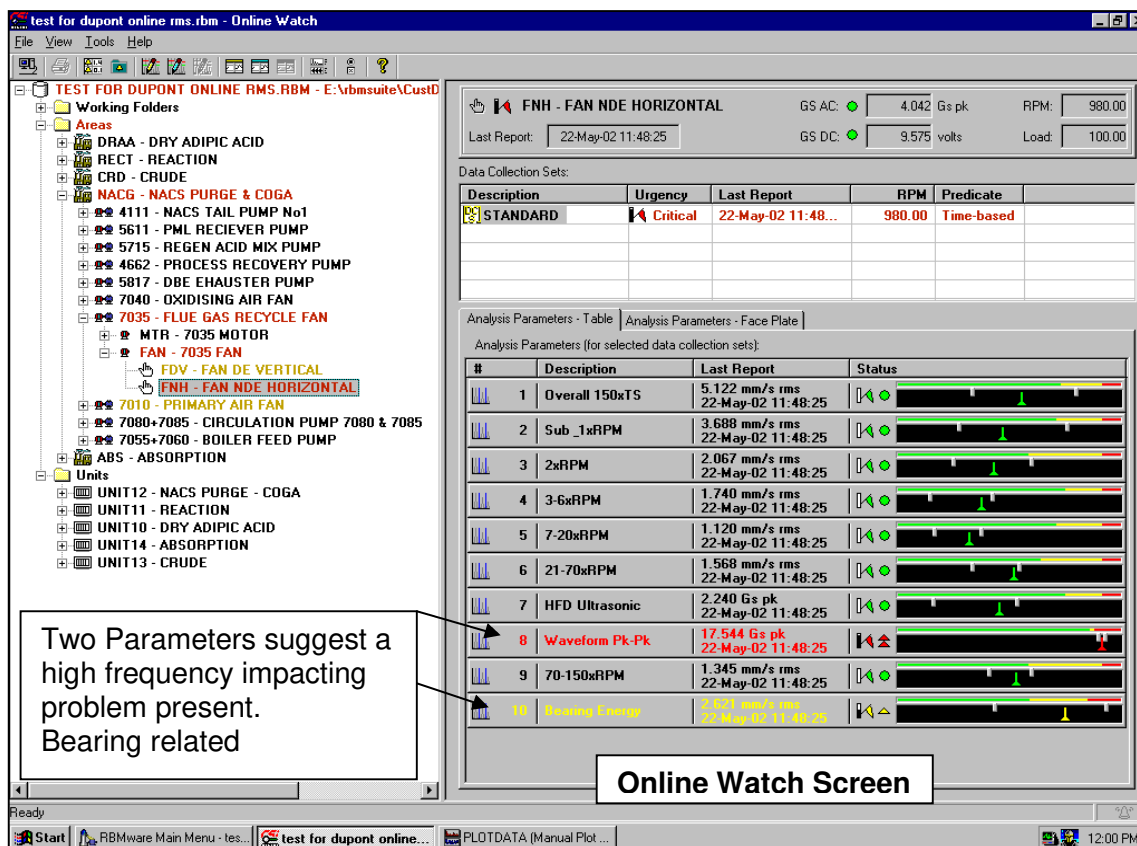
**Online Watch Screen**

In Mid May 2002 the Flue gas fan sensor (**Fan Non Drive End Fan Horizl**) entered into an alarm condition, the system automatically started rapid data collection. Two parameters were initially in alarm PK-Pk Waveform, (Peak to Peak Value of time waveform measured in G's) and a Bearing energy band also measured in G's. Below is the **Online watch screen** showing the status of monitored plant.

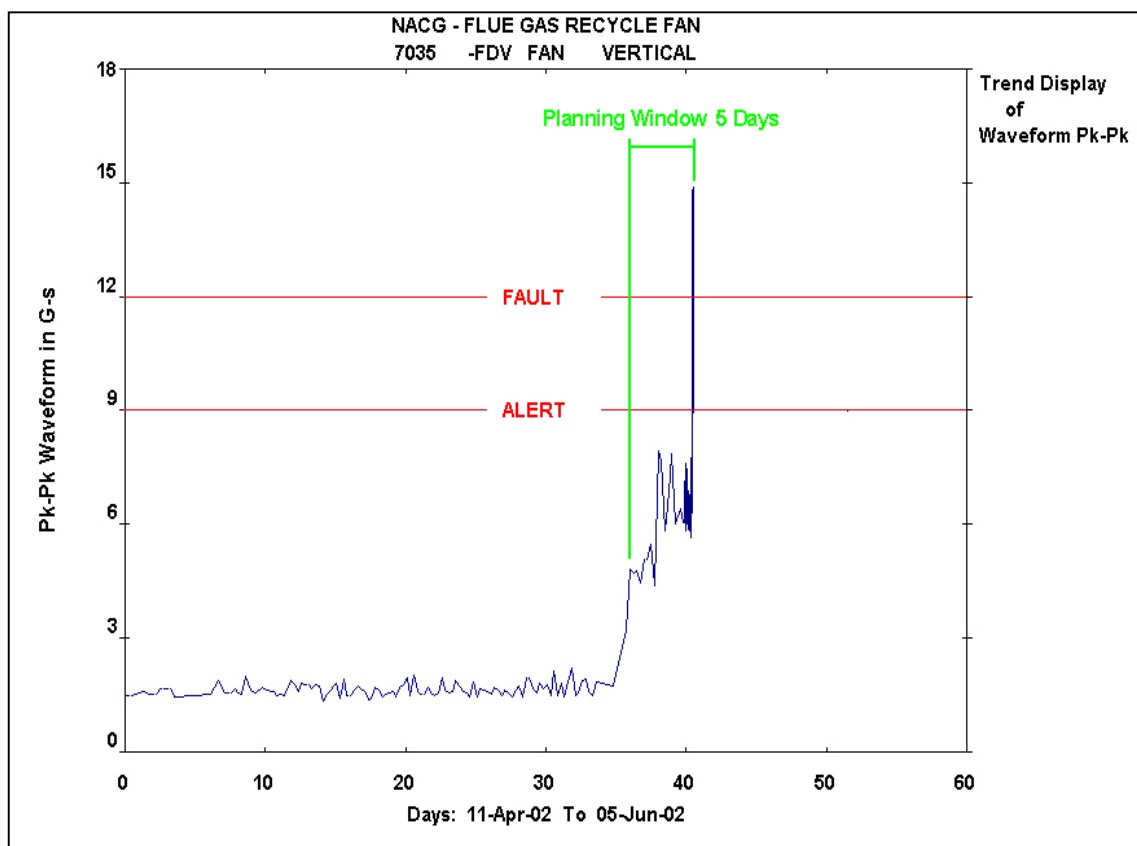
The above online trend is taken off the Fan Non Drive End Sensor; note how quick the fault is deteriorating. Planning windows are rare on the coga unit due to the environmental consequences if the plant is shut down.

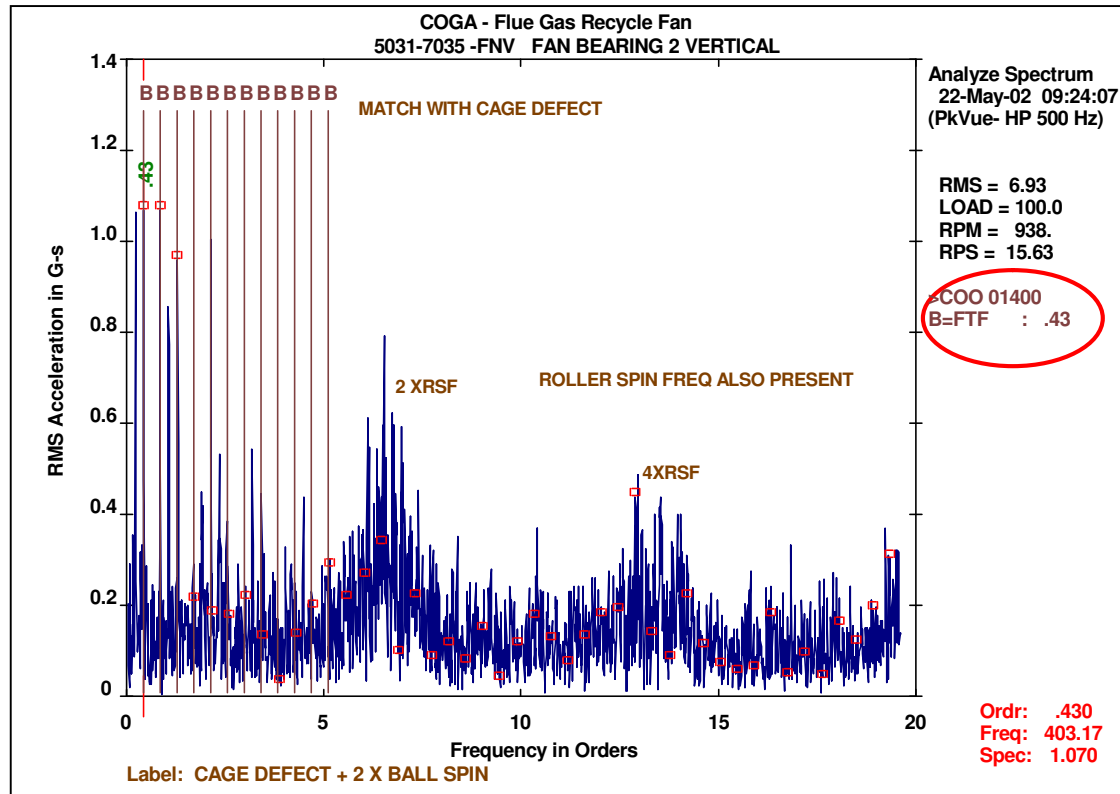
The filtered spectrum above indicates a problem with the cage and rollers on the NDE fan bearing, a clear match is made with the cage ( 0.4 orders ). 2X Roller spin freq is also present due to defects on the rollers impacting the inner and outer races as they rotate. Cage defects are well known to deteriorate quickly.

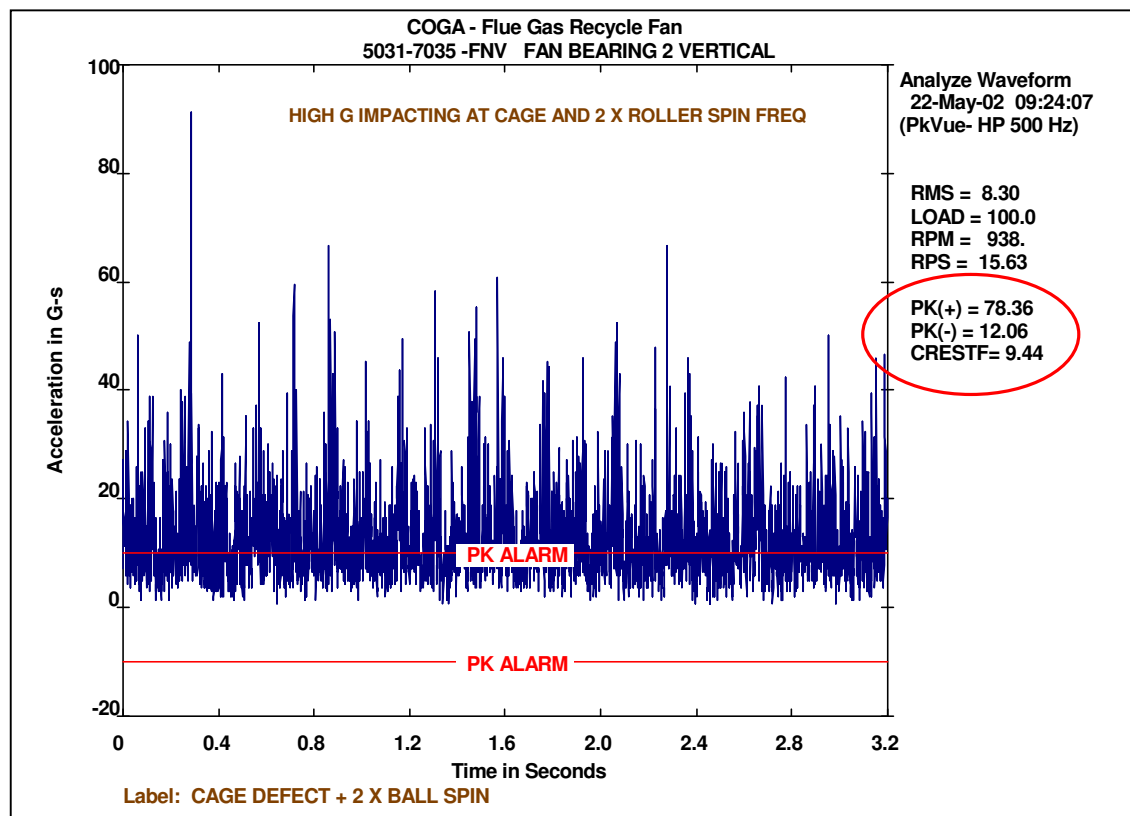
The time waveform shows impacting to 78 G's, severe bearing damage.

After discussions with production and maintenance, the reliability team decided to plan for the fan bearings to be changed at the earliest opportunity. New bearings were ordered and a scaffold erected ready for a quick bearing change. The opportunity came on the 21<sup>st</sup> May when the Dryer Plant shut down on an overload issue. The coga was still running at this point, so a plan was formulated to shut the flue gas fan down in controlled manner so that the coga unit could still be run, but at reduced rates, this was only possible because of the Dryer plant shutting down.

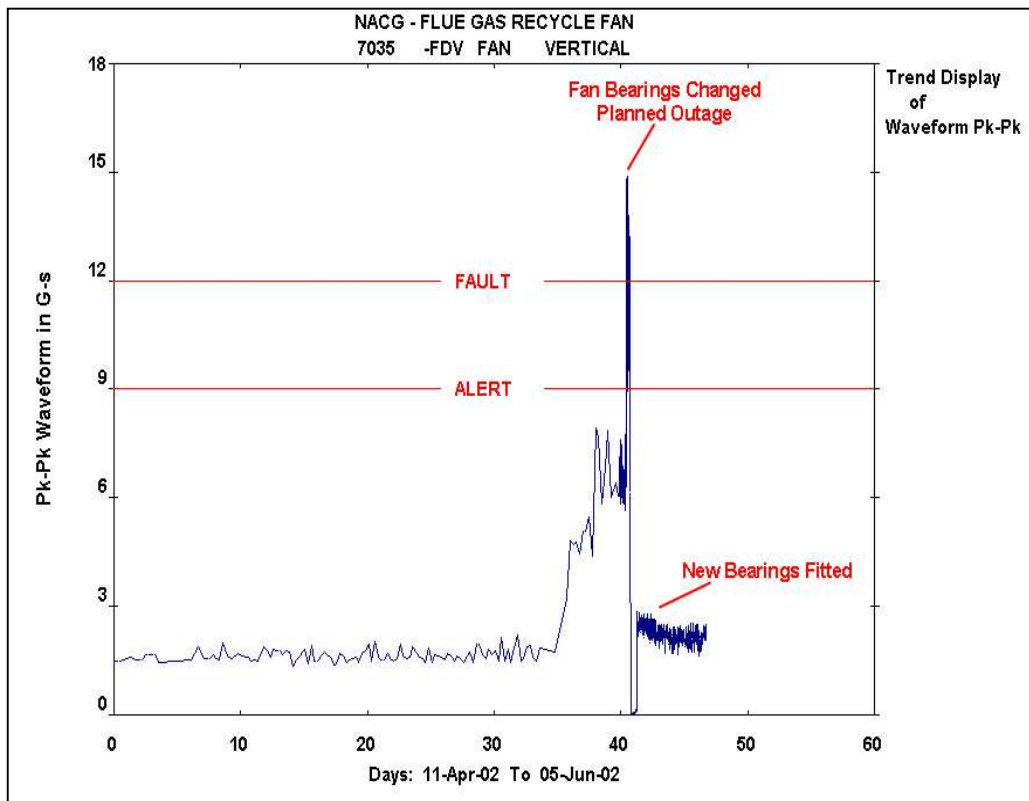
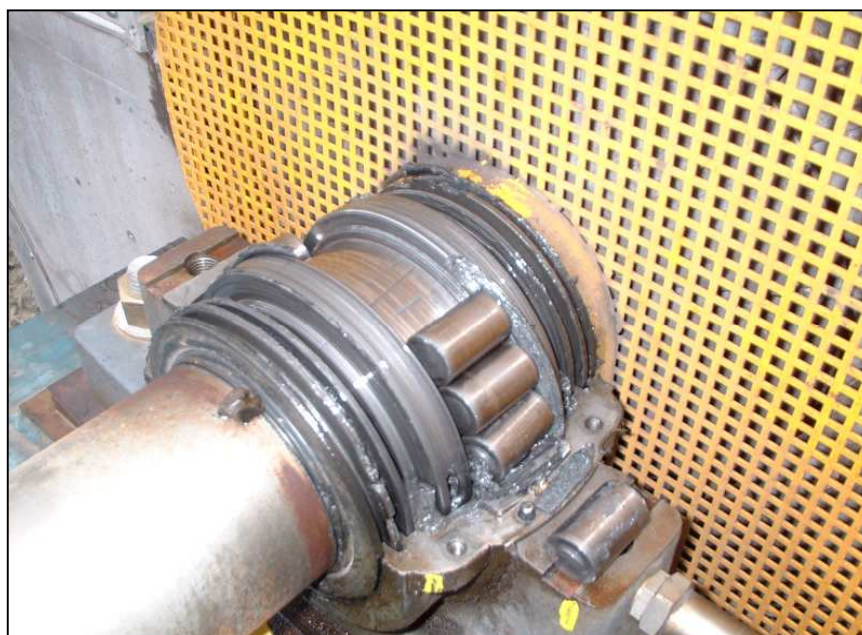
Upon inspection of the bearing it was found that the cage had disintegrated and the bearing had entered the final failure mode. The fan would have failed catastrophically later that day, this would have caused major shaft and fan damage. The bearings were replaced and the fan was running within 6 Hours.

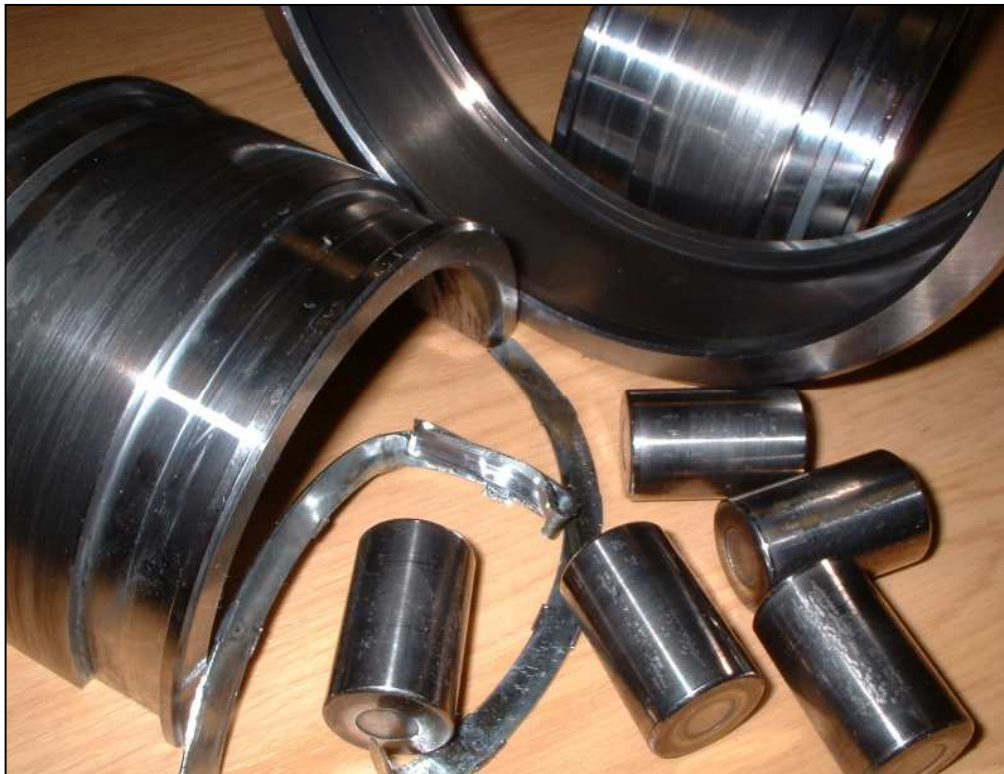
The cleaned up NDE cooper fan bearing showing remains of the cage and the damaged rollers.
