No.1 DRYER. DRAA

Drying Air Fan

5031-3181

Case Study

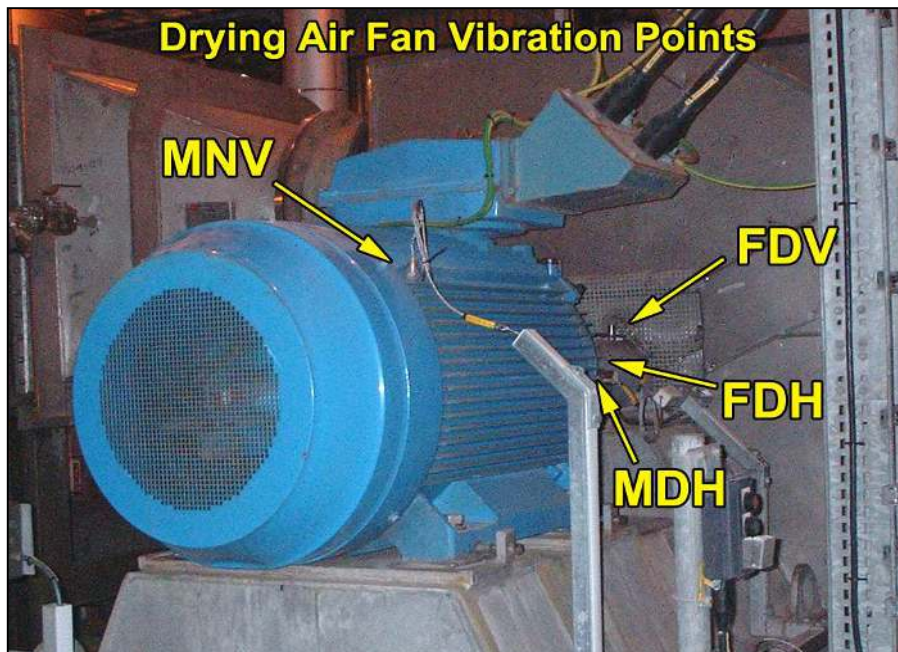
The above Photo illustrates the position of the fixed online vibration sensors that are fitted to the fan and motor (i.e. MNV = Motor Non Drive End Bearing Vertical).

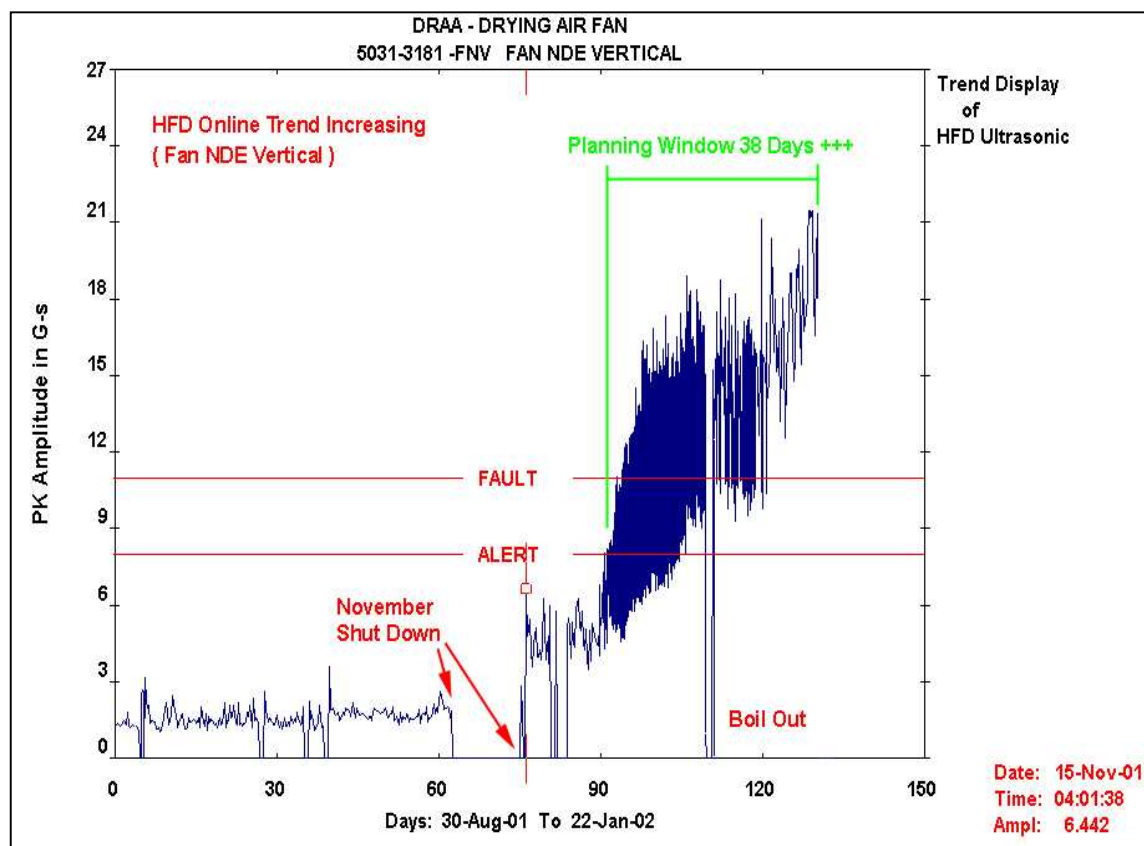
The above online trend is taken off the Fan Non Drive End Sensor; note the step change in vibration after the November Shutdown. The trend above also shows the possible planning options.

After discussions with production and maintenance, it was decided to take advantage of the next boil out and replace the fan bearings within this **planned shutdown**. Boil outs are dictated by production parameters, they are however useful for minor

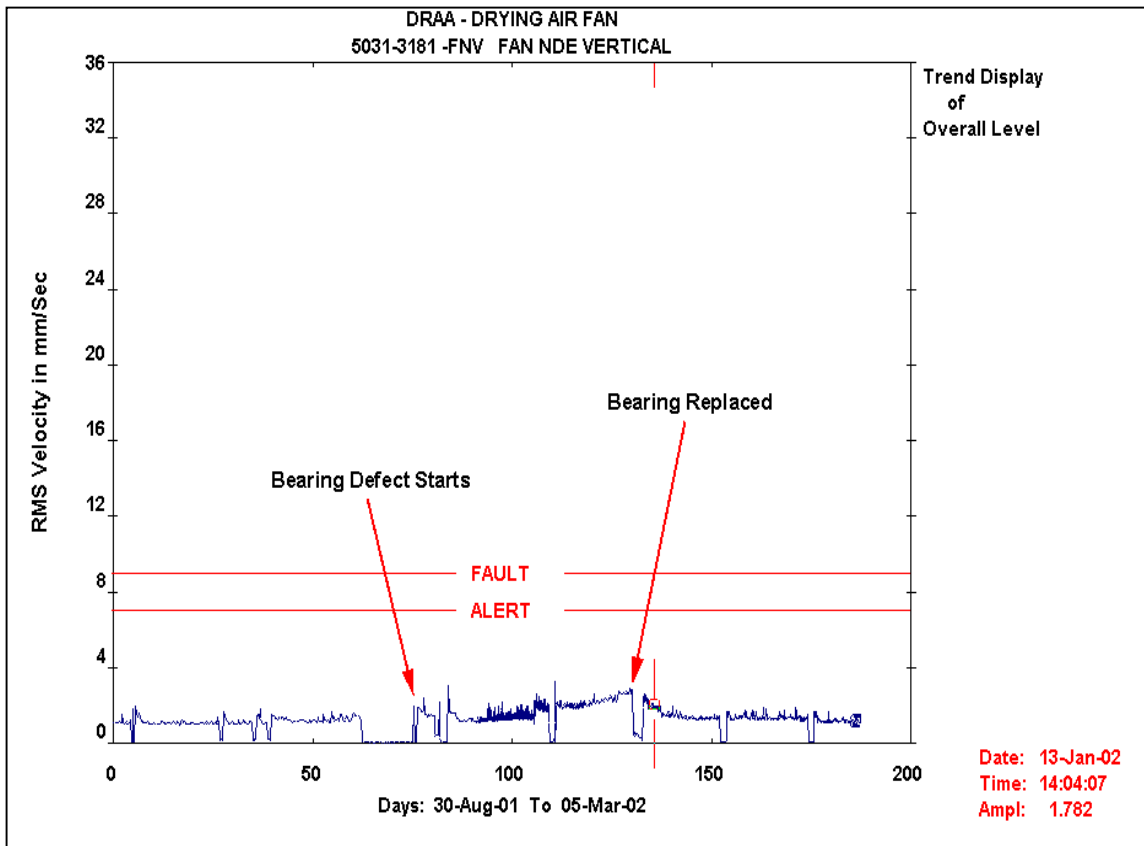
Above trend shows overall level of vibration as bearing defect degrades. Note only a minor change in overall vibration levels.

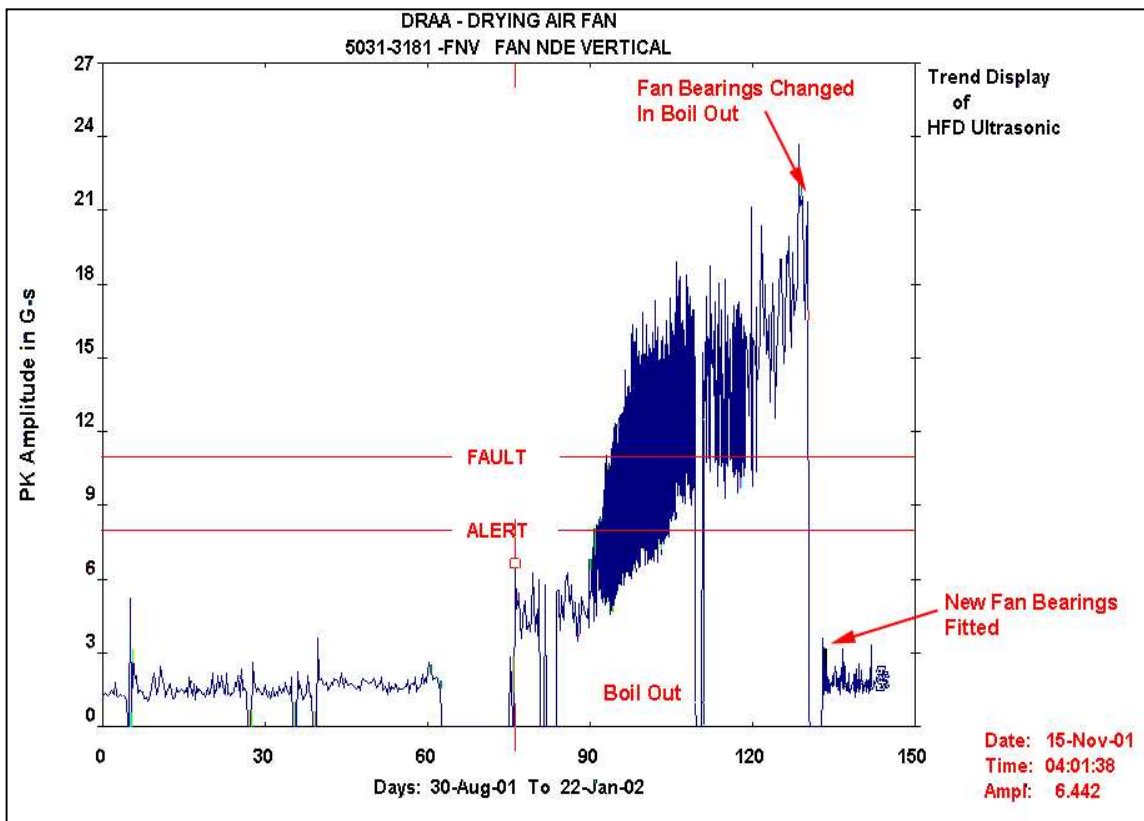
HFD Trend clearly shows bearing defect degrading.

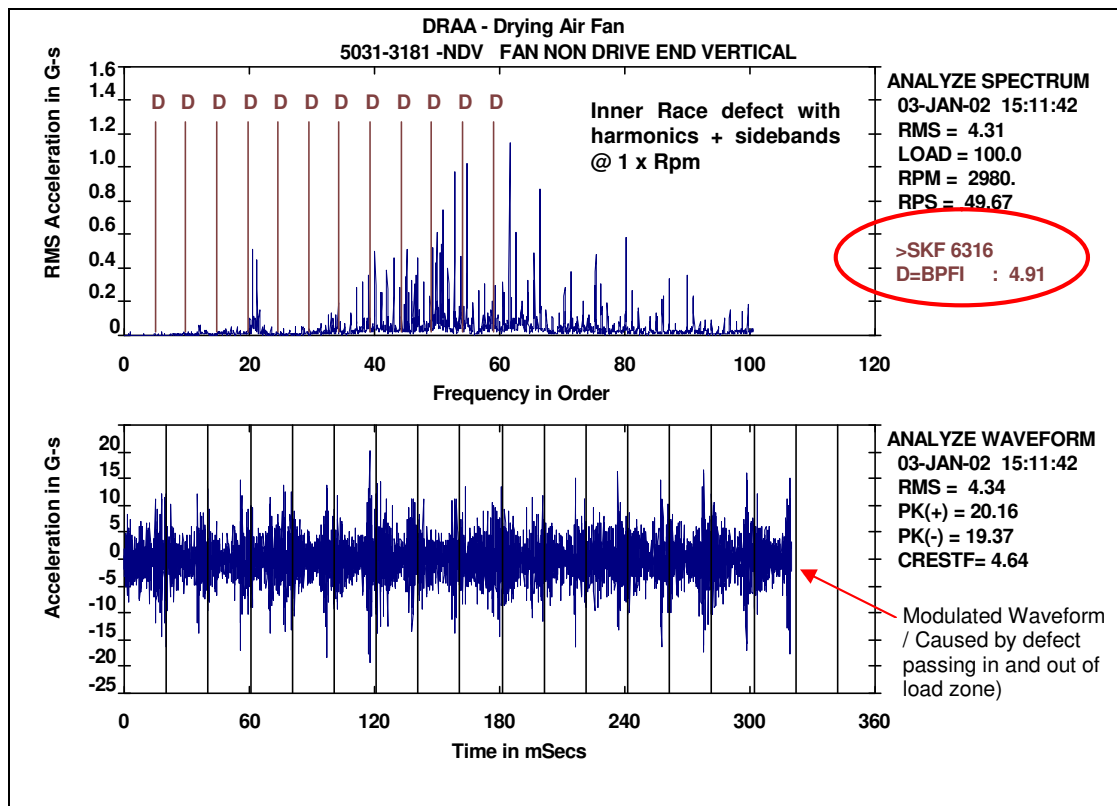
The spectrum above shows multiple harmonics starting from 4.91 orders. This pointed towards a possible bearing defect, all the bearing defect frequencies were overlaid and a match was found with the inner race of the fan bearings (**Skf 6316**). The data indicated that an **inner race defect** was present at the Fan NDE.

maintenance work. Carrying out the fan bearing changes at this time incurred no downtime because it was a planned outage.

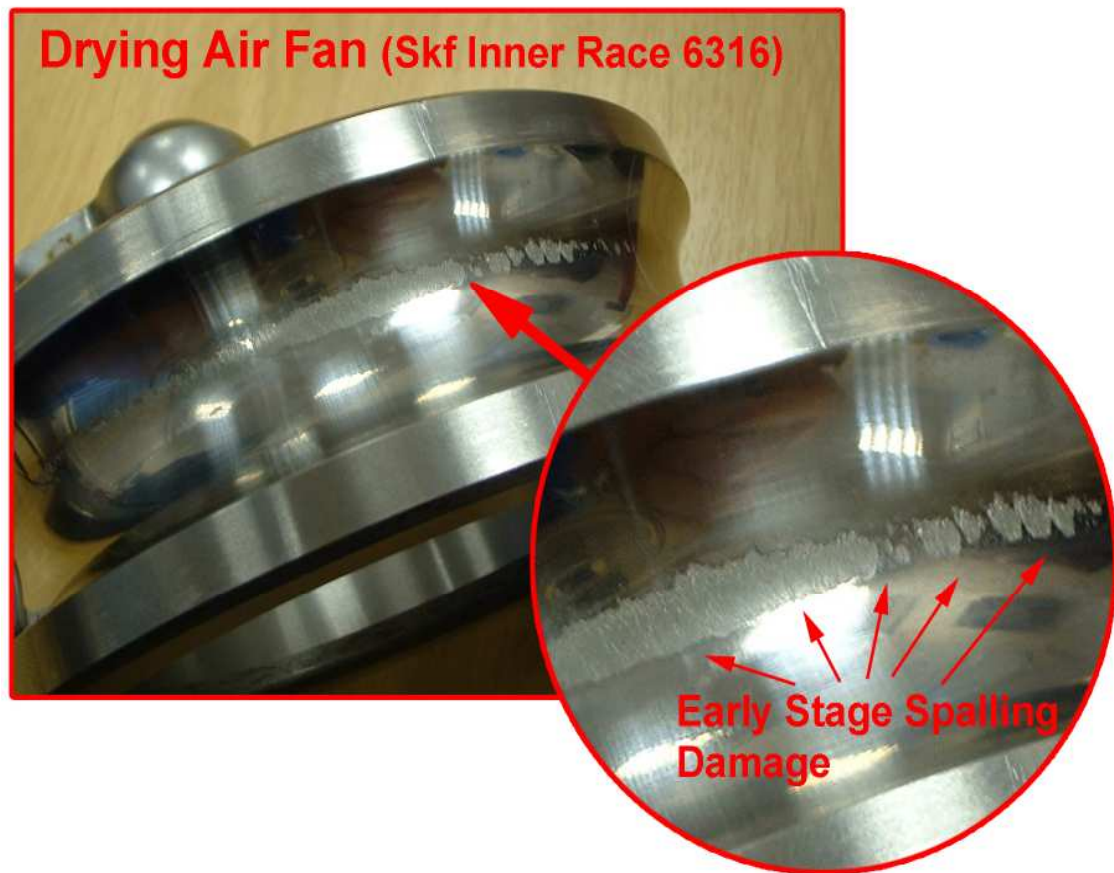
After the Job was completed the fan bearings were inspected for the predicted damage. Below is a photo of the inner race off the fan NDE bearing.
