Vibration Analysis

Case Study – Gas Recycle Fan

Presentation by: Stuart Walker

Reliability Maintenance Solutions Ltd

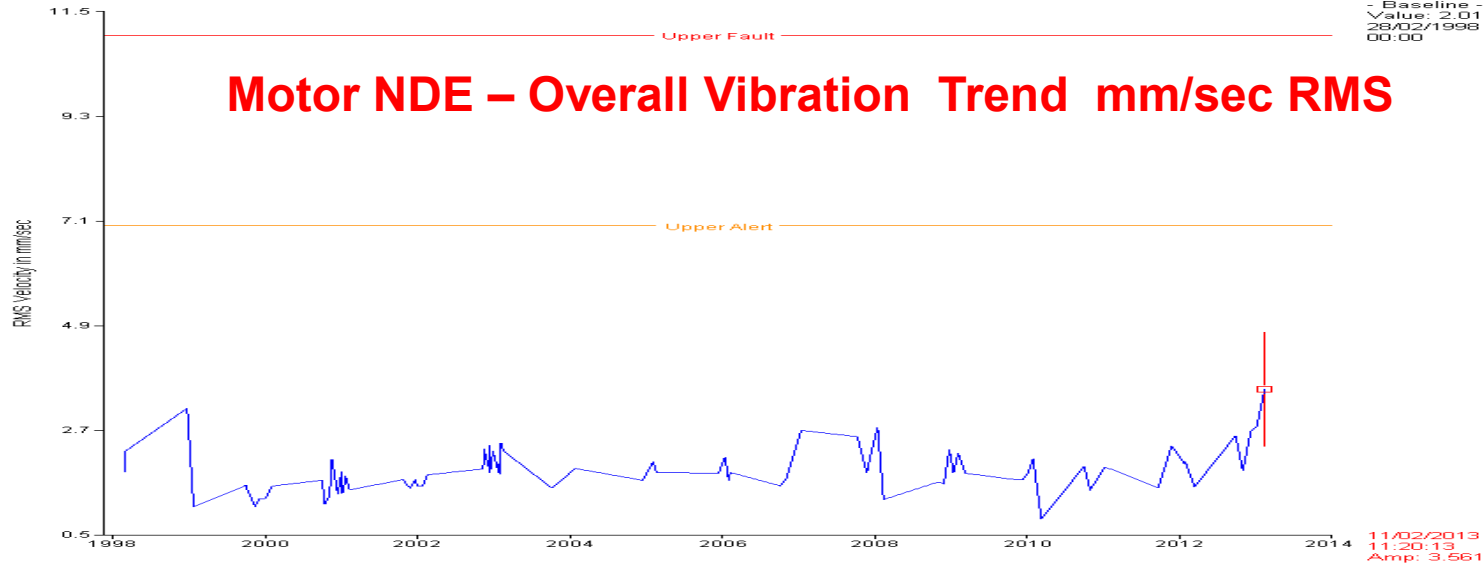
Motor NDE – Overall Vibration Trend mm/sec RMS

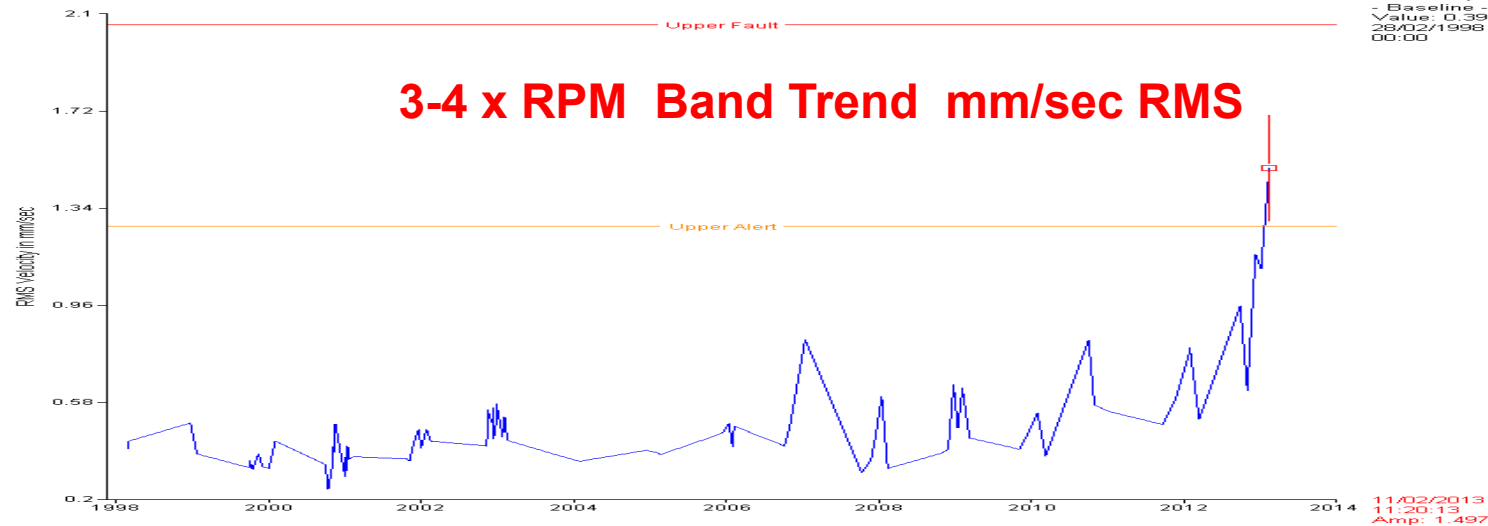
3-4 x RPM Band Trend mm/sec RMS

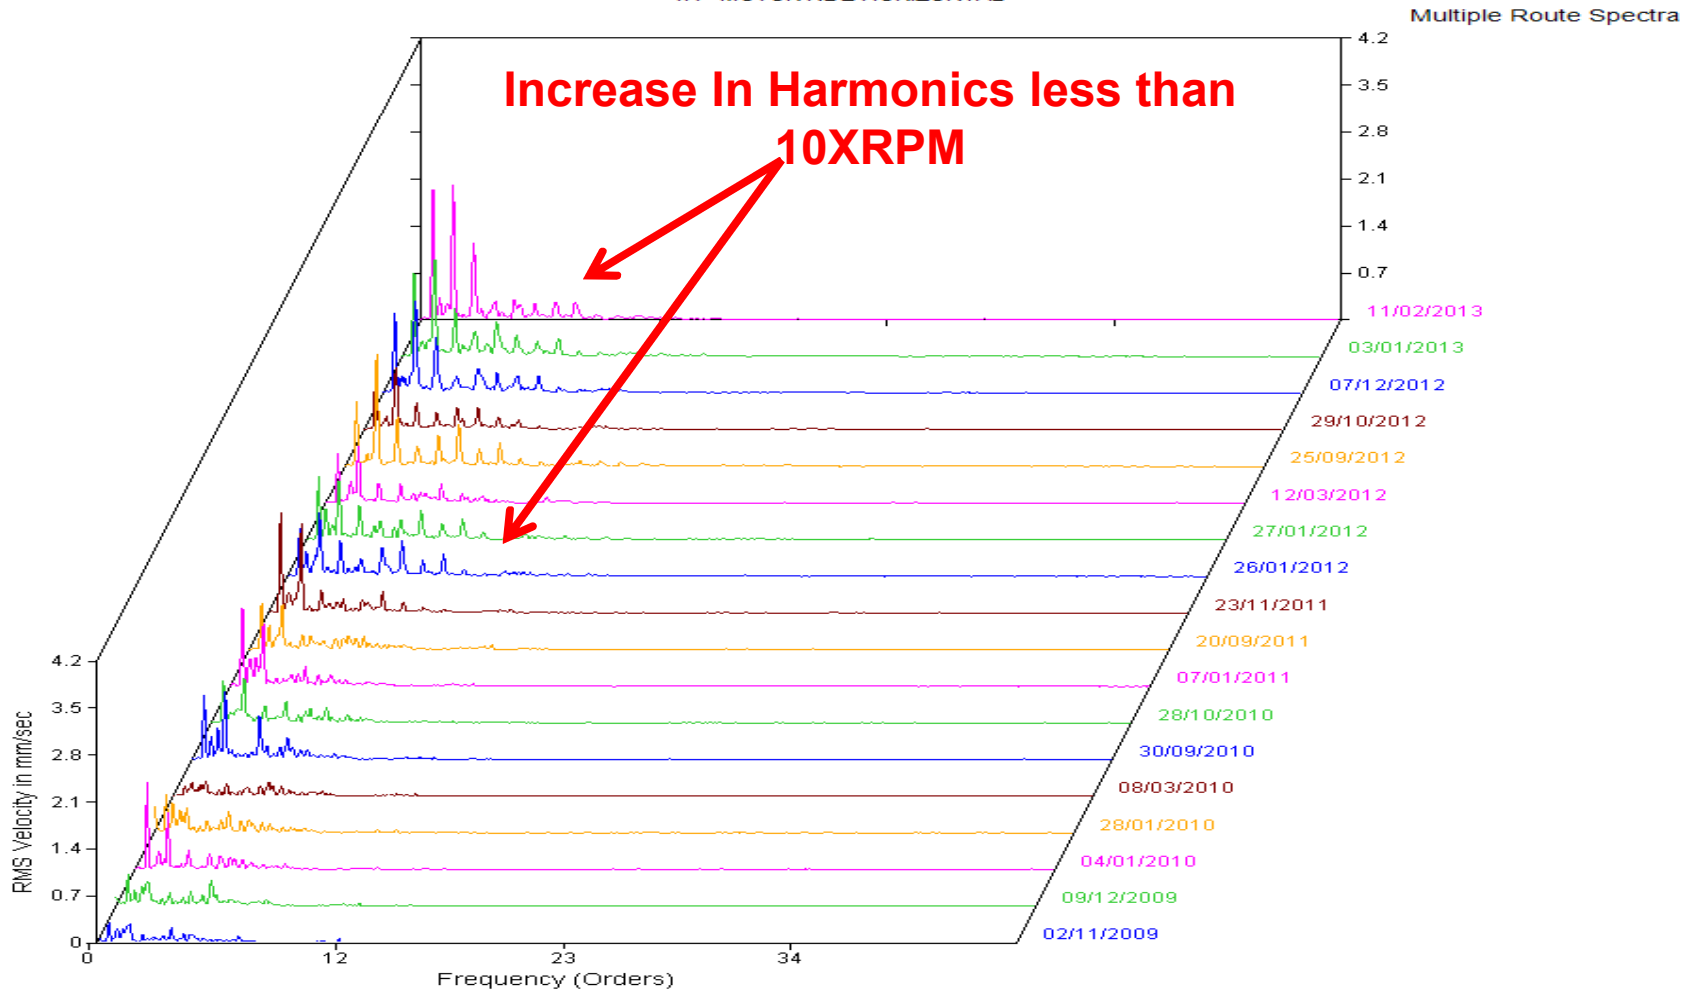
Multiple Spectrum History Plot- Motor NDE Horiz

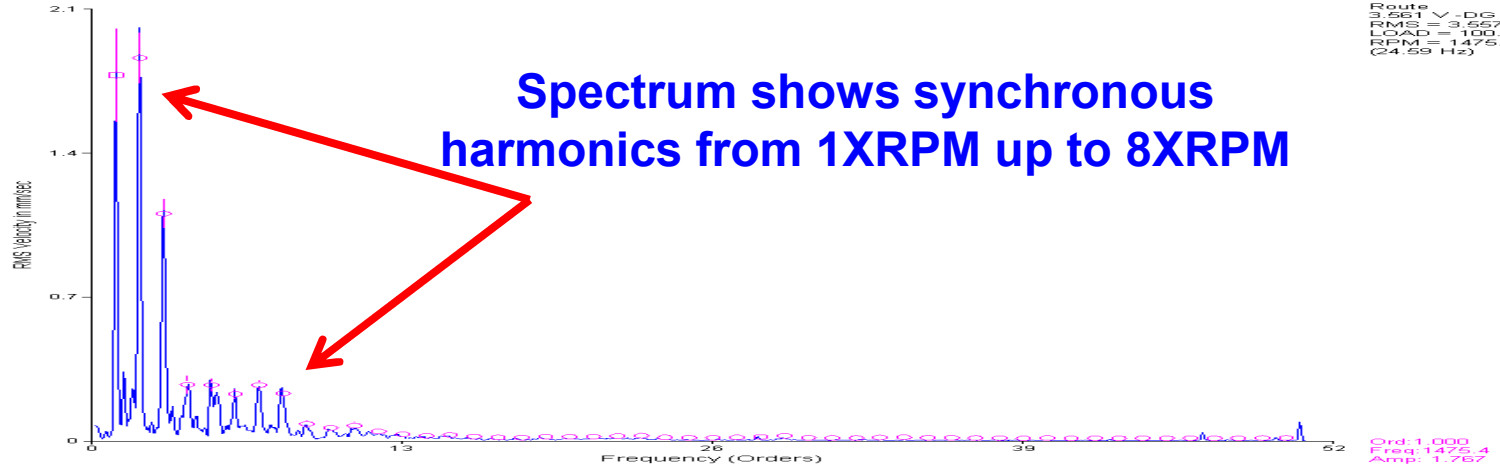
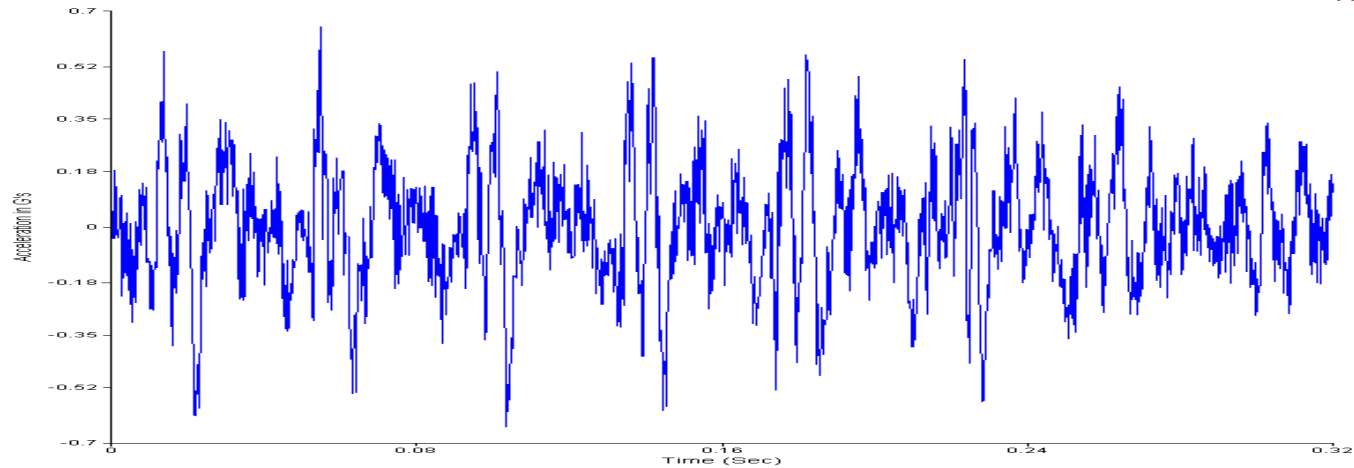
11/02/2013 11:20:13
Route
3.561 V.DG
RMS = 3.557
LOAD = 100.00
RPM = 1475.4
(24.59 Hz)

11/02/2013 11:20:13
Route
RPM = 1475.4
(24.59 Hz)
LOAD = 100.00
RMS = 0.199
Pk(+) = 0.650
Pk(-) = 0.643
Crest = 3.271

Spectrum & Waveform - Motor NDE Horiz

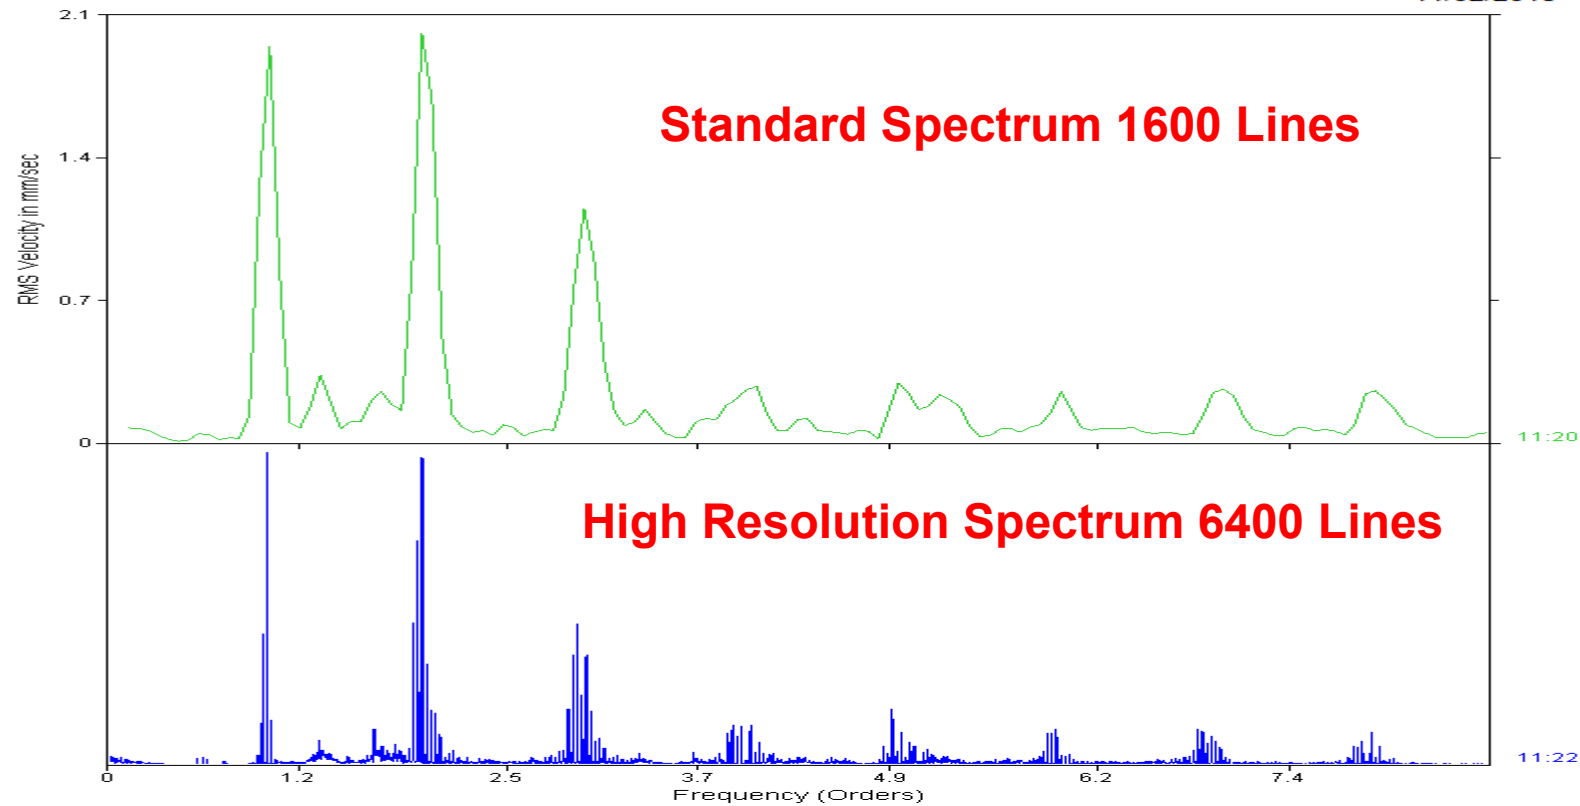
High Resolution 6400 Line spectrum shows clear sidebands surrounding the 1-8 XRPM harmonics

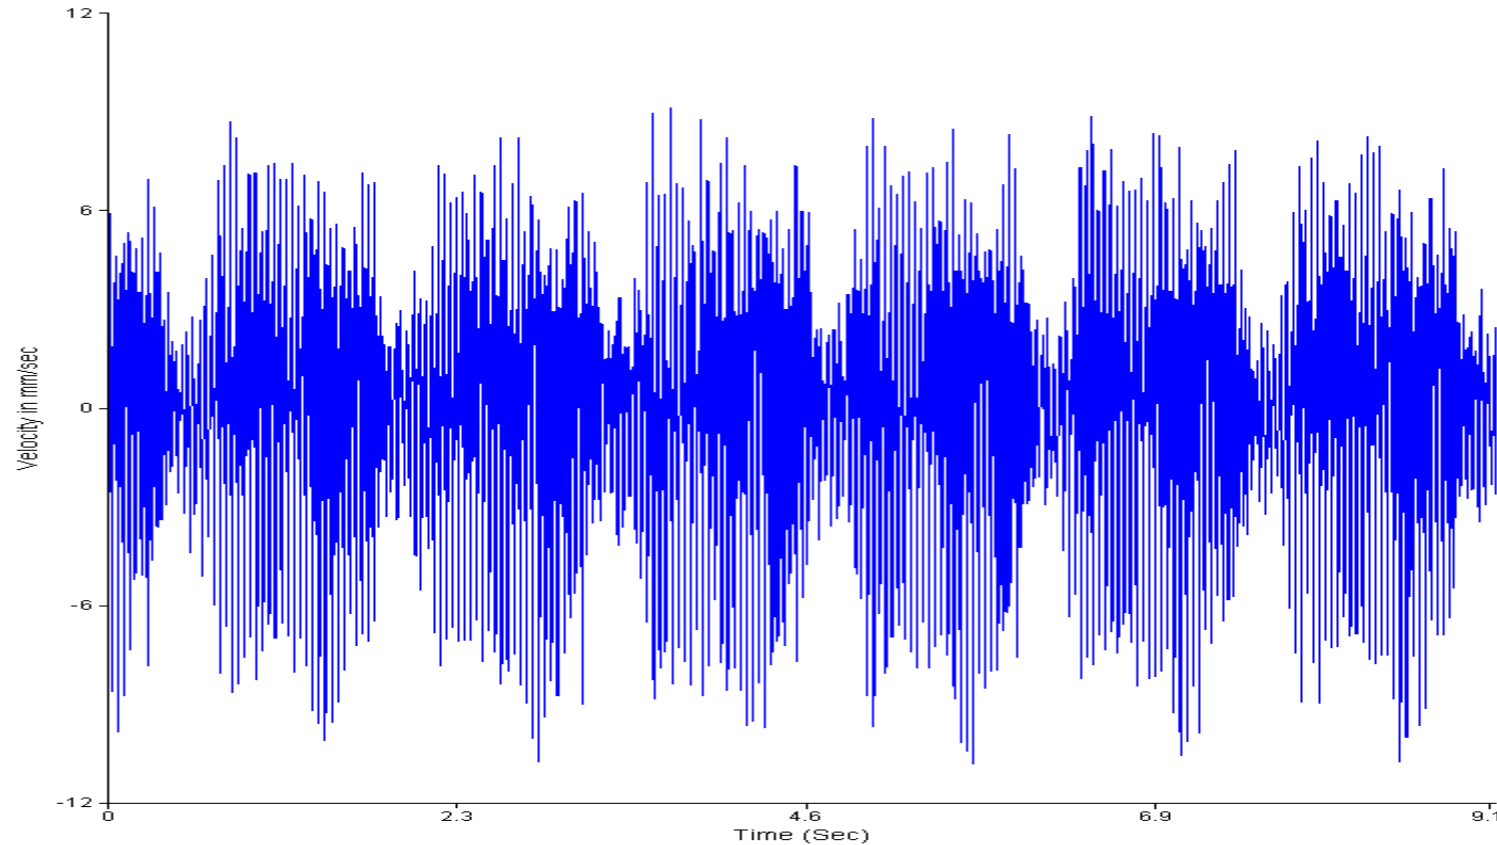
**Extended Time Waveform clearly shows a regular “Beat” is present,
this was also audible.**

40 Cycles per min matches the spacing of the modulation sidebands surrounding the 1xRPM harmonics. This is also the frequency of the “Beat”

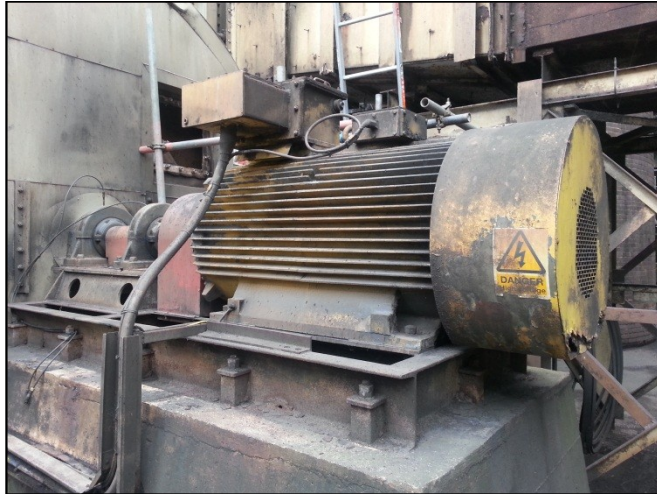
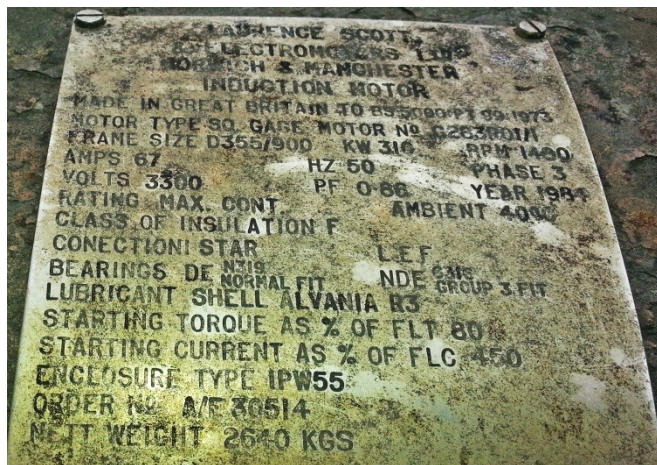
- Induction Motor
- Power 315 KW
- 1500 RPM.
- Actual Running Speed 1490 RPM
- 4 Poles
- Rolling Element Bearings

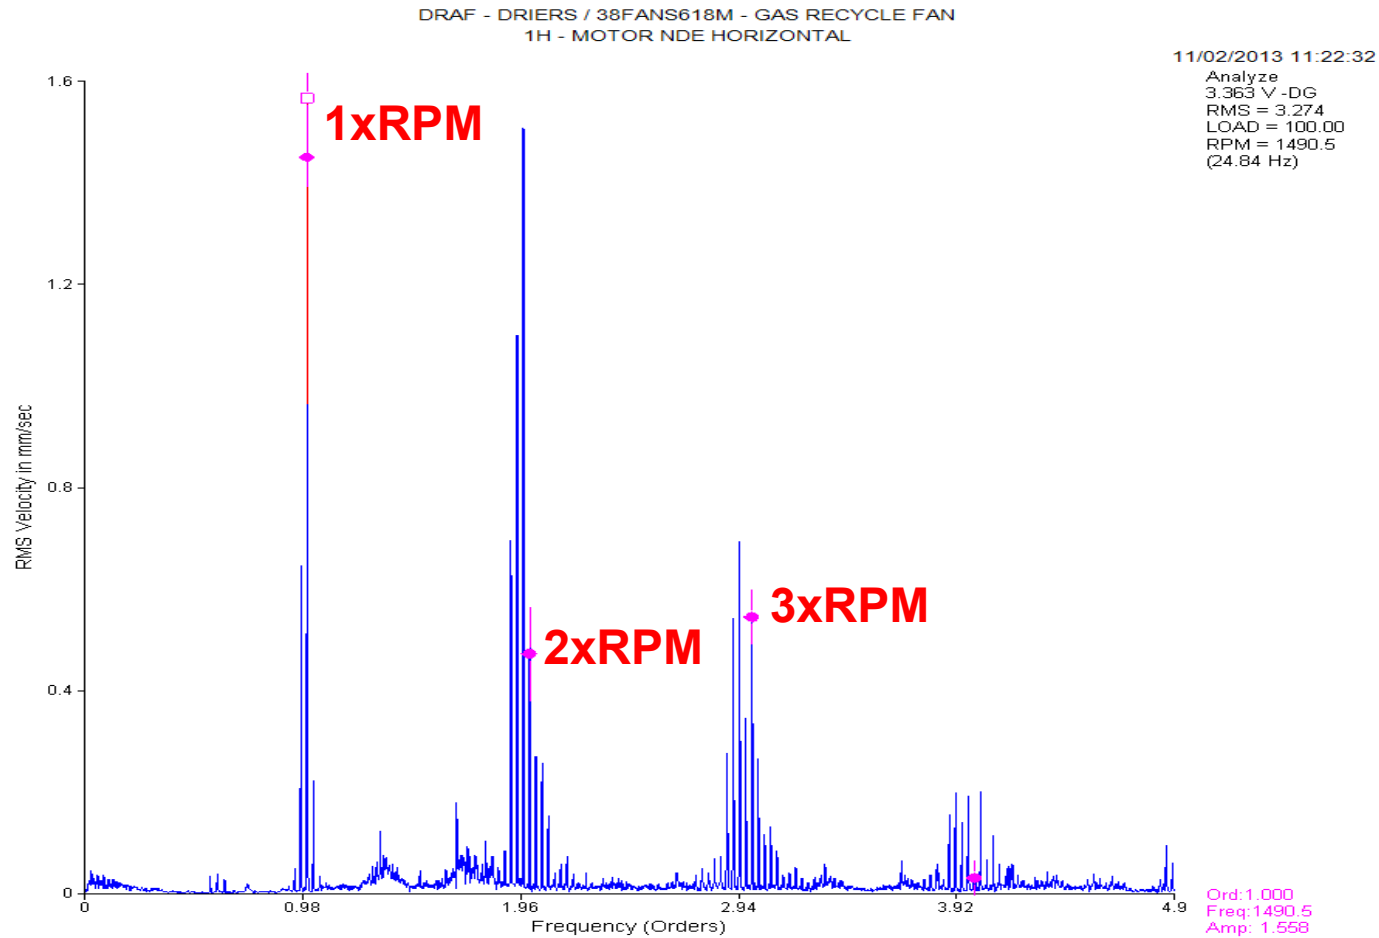
High Resolution spectrum shows run speed harmonics surrounded by modulation sidebands

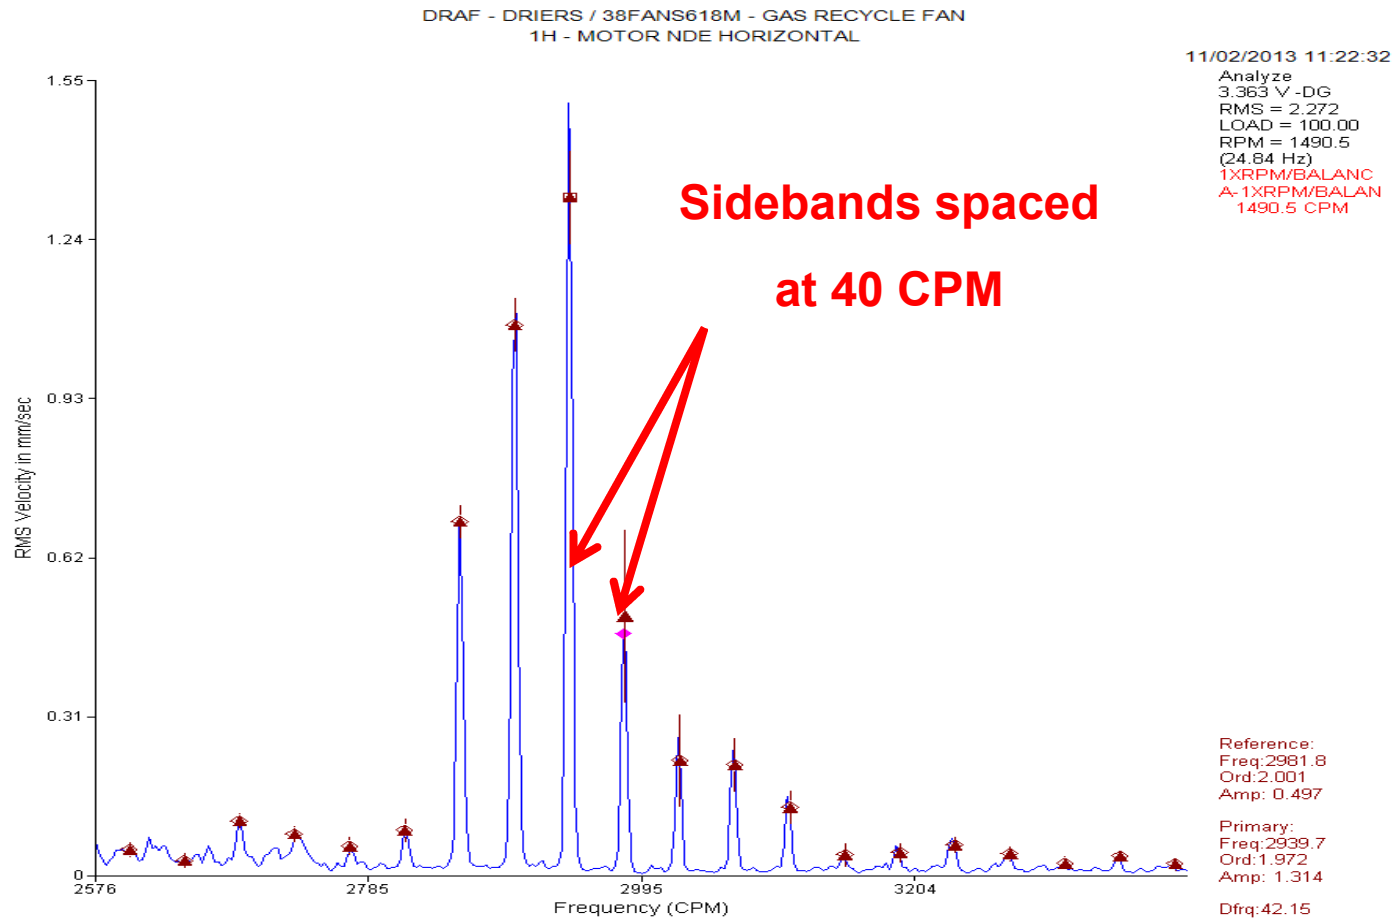
Sidebands measured at 40 CPM (Cycles Per Min)

Suspected Rotorbar Problem

Rotorbar Defect Freq = No. of Poles x Slip Frequency

1500 RPM – 1490 RPM = **10 CPM Slip Frequency**

4 Poles x 10 CPM Slip Freq = **40 Cycles Per Min**

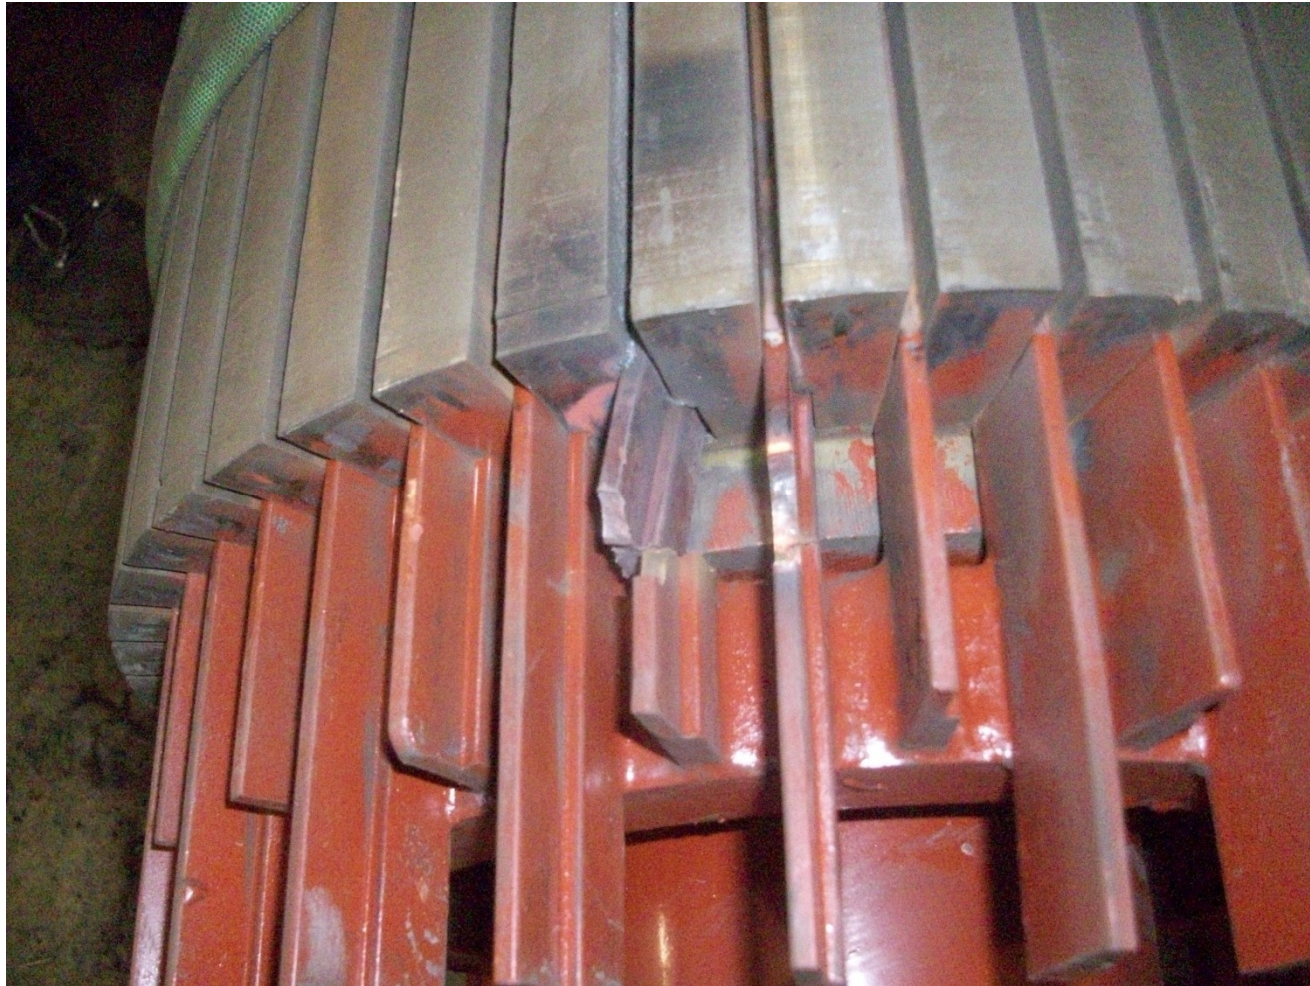
Rotorbar Defects Present on Motor

Upon Inspection - Rotobar found to be cracked
