# Primary Air Fan COGA Unit

## Fault Analysis Report

## 5031-7010 Primary Air Fan (Fan DE Bearing Problem)

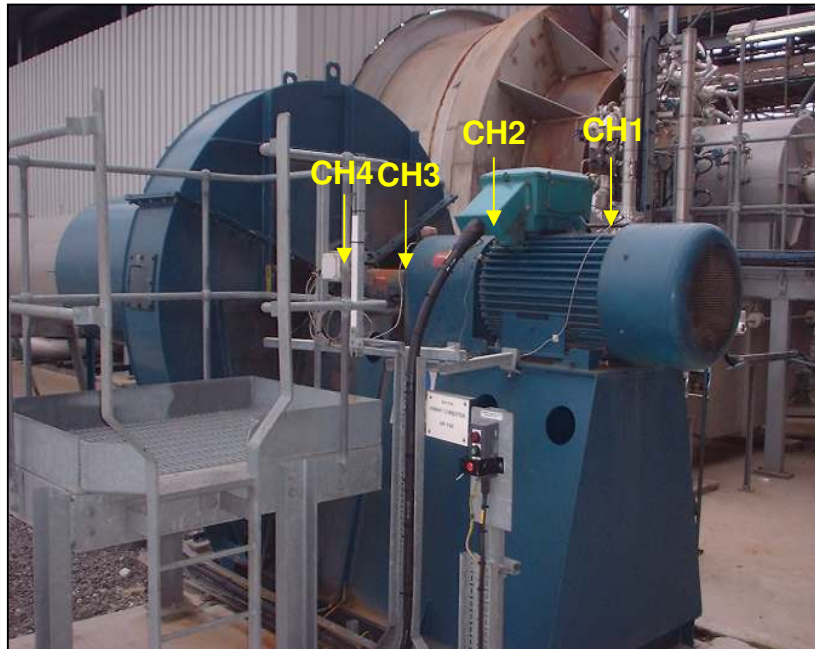
The Primary Air fan is a key part of the COGA Unit; it supplies atmospheric air to the furnace to allow the combustion process to take place. Failure of this asset will result in COGA shutdown, and heavy plant losses.

The fan has four fixed vibration sensors which are wired into the 6500 Online System, the data is sent back to a PC where trending & analysis takes place.
