# **COGA Unit Flue Gas Recycle Fan 5031-7035**

## **Online Vibration Case Study**

## 5031-7035 Flue Gas Recycle Fan (Online Case Study)

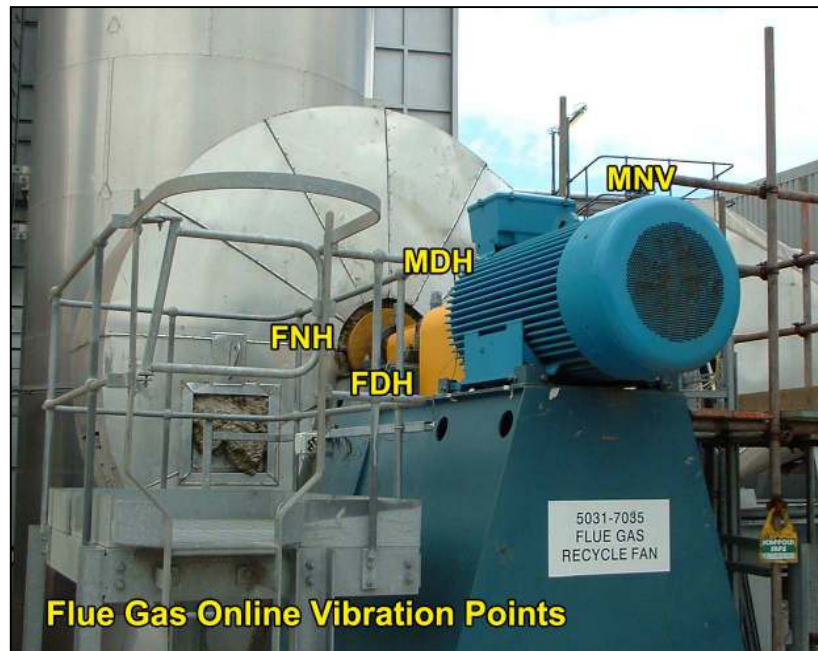
The above Photo illustrates the position of the fixed online vibration sensors that are fitted to the fan and motor (i.e. MNV = Motor Non Drive End Bearing Vertical).
