No.1 DRYER. DRAA

Drying Air Fan

5031-3181

Case Study

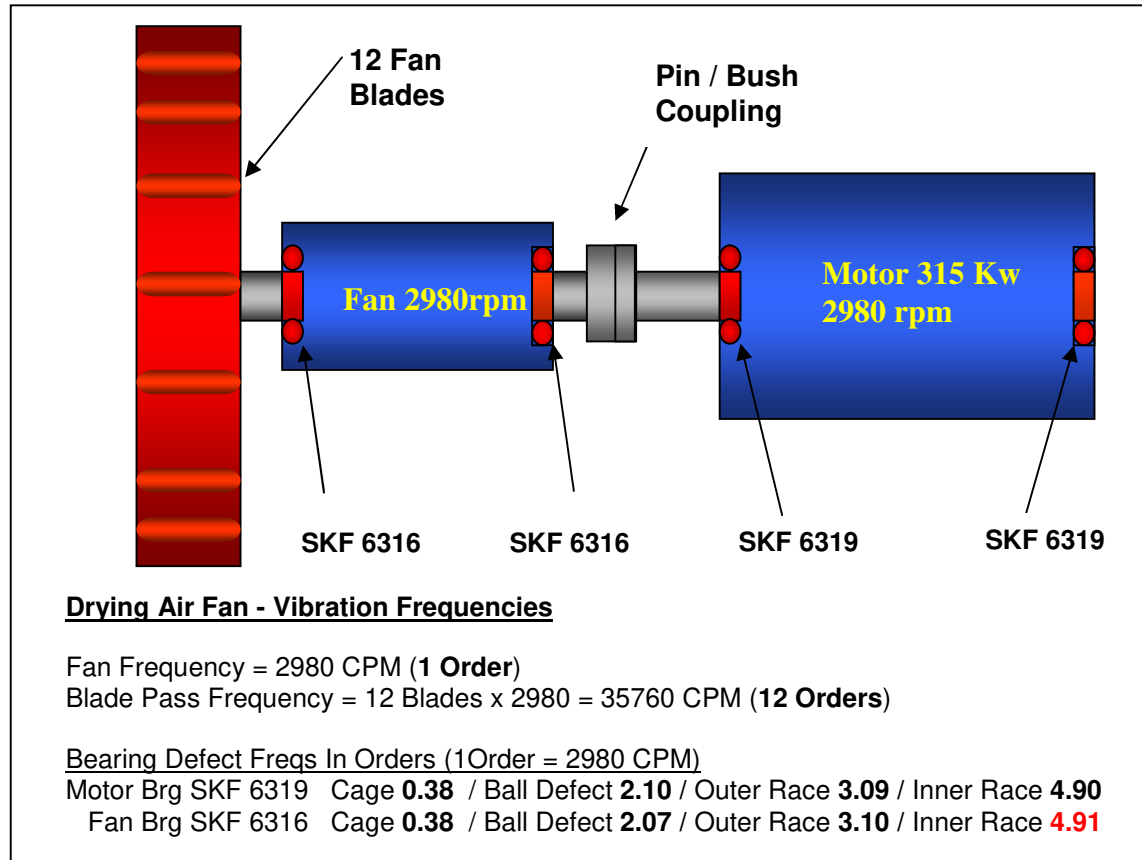
The above diagram shows the configuration of the Drying air fan. The above configurations, speeds, bearing details etc have being entered into the online system to assist in fault diagnostics.
